# Four Mile Creek

## Rapid Geomorphic Assessment & Conceptual Restoration Plan

Niagara Peninsula Conservation Authority

14 December 2022

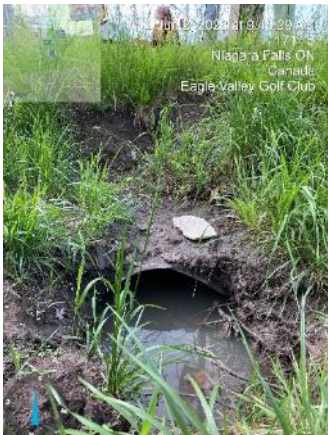
| Reach | Site No. | Photo | Issues | Priority |
|---|---|---|---|---|
| U/S of Reach 1 | 0-1 | | Erosion and slumping around an open section of culvert on the east side of St Paul Avenue north of Mountain Road.<br><br>Feature Type: Crossings (C) | Monitor / Level 2 priority<br>(0 – 5 years) |

| Reach | Site No. | Level / Category | Recommended Treatment | Cost |
|---|---|---|---|---|
| U/S of Reach 1 | 0-1 | 3 (C) | Repair erosion around culvert in open section of channel | \$18,600 |

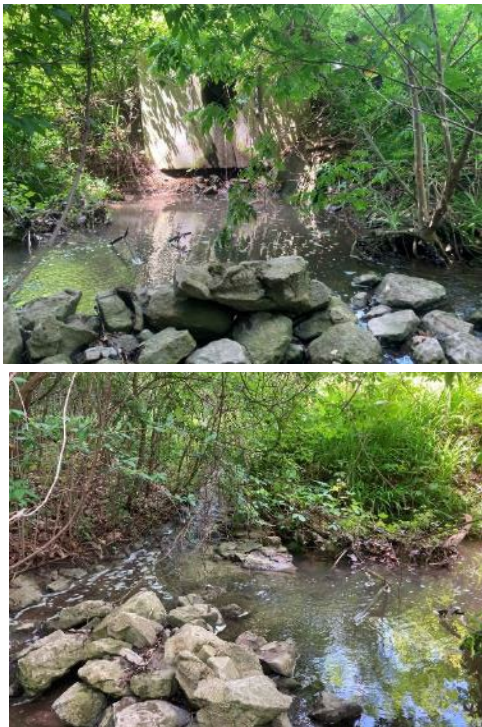
| Reach | Site No. | Photo | Issues | Priority |
|---|---|---|---|---|
| 1 | 1-1 | | Stormwater outlet on left bank elevated with scour pool below and erosion around headwall. Flow undermining and outflanking concrete channel lining.<br><br>Feature Type: Existing In-Channel Structures (E) | Monitor/Level 2 Priority (0 – 5 years) |

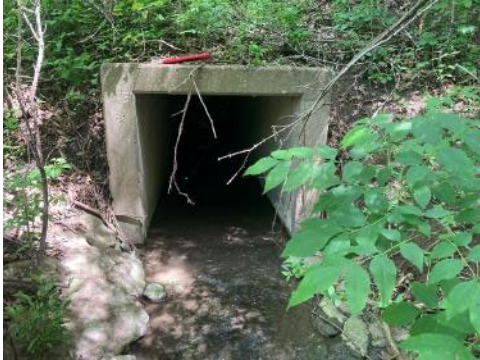
| Reach | Site No. | Photo | Issues | Priority |
|---|---|---|---|---|
| 1 | 1-2 | | Concrete culvert inlet at CN rail crossing slightly undermined.<br><br>Feature Type: Crossings (C) | Monitor/Level 3<br>Priority (5 – 10 years) |

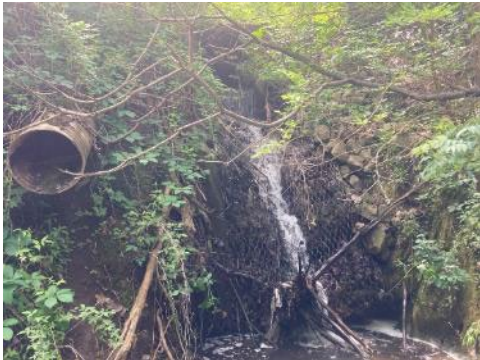
| Reach | Site No. | Photo | Issues | Priority |
|---|---|---|---|---|
| 2 | 2-1 | | Concrete culvert outlet downstream of CN rail elevated over 5 m, failed gabions, and scour pool.<br><br>Feature Type: Crossings (C) | Monitor/Level 2<br>Priority (0 – 5 years) |

| Reach | Site No. | Level / Category | Recommended Treatment | Cost |
|---|---|---|---|---|
| 2 | 2-1 | 2 (C) | Repair/replace drop structure and stabilize scour pool | \$312,000 |

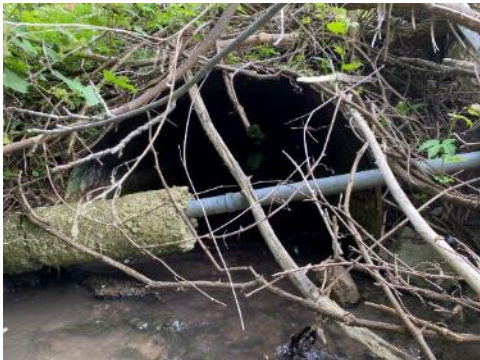
| Reach | Site No. | Photo | Issues | Priority |
|---|---|---|---|---|
| 3 | 3-1 | | Fallen fence post and debris downstream of culvert outlet under driveway/road.<br><br>Feature Type: Existing In-Channel Crossings (C) | Monitor/Level 2<br>Priority (0 – 5 years) |

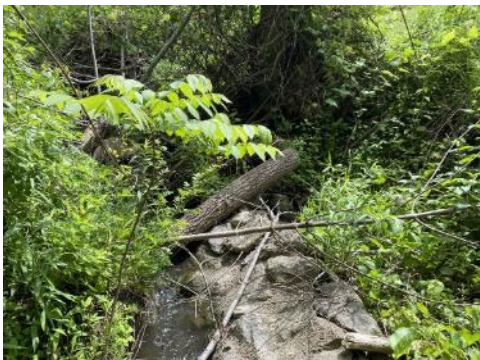
| Reach | Site No. | Photo | Issues | Priority |
|---|---|---|---|---|
| 3 | 3-2 | | Concrete bed lining outflanked along St Paul Avenue road embankment.<br><br>Feature Type: Existing In-Channel Structures (E) | Monitor/Level 3<br>Priority (5 – 10 years) |

| Reach | Site No. | Level / Category | Recommended Treatment | Cost |
|---|---|---|---|---|
| 3 | 3-2 | 3 (E) | Remove concrete and repair with bed and bank treatment | \$198,000 |

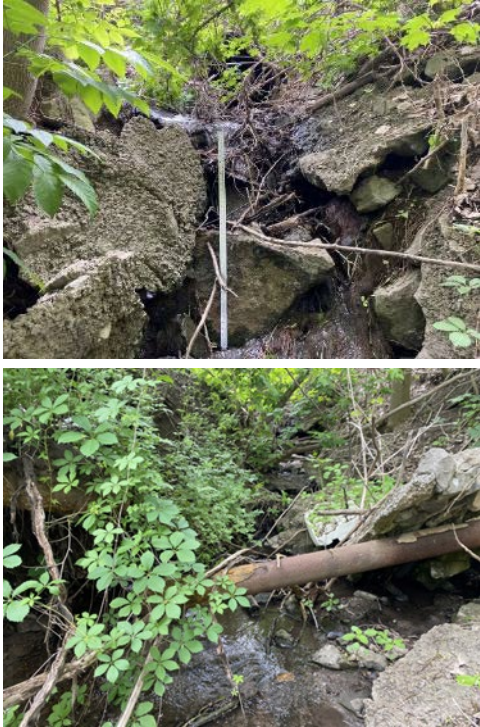
From the first pond outlet, Reach 3 continued alongside St Paul Avenue at a steep gradient. The upstream portion of this reach was lined with concrete which had failed, creating a 1 m drop. The 1 m drop is located approximately mid-reach, downstream of a stormwater outlet where the creek bends away from the road. Further downstream there was a transition to low-bed morphology before the second pond outlet. Reach 4 was a poorly defined channel through a wetland area downstream of the pond outlet. The creek then flowed through a concrete culvert under Highway 405. The culvert outlet was undermined and outflanked due to the flow from an incoming drainage channel to the east. Approximately 2 m downstream of the Highway 405 culvert outlet, the creek entered another concrete culvert which passed under Townline Road.

| Reach | Site No. | Photo | Issues | Priority |
|---|---|---|---|---|
| 3 | 3-3 | | <p>Failed concrete bed and 1 m drop downstream of stormwater outlet on the east side of St Paul Avenue. Concrete debris and pipes in channel downstream and significant bank erosion.</p> <p>Feature Type: Existing In-Channel Structures (E)</p> | Monitor/Level 2<br>Priority (0 – 5 years) |

| Reach | Site No. | Level / Category | Recommended Treatment | Cost |
|---|---|---|---|---|
| 3 | 3-3 | 3 (E) | Remove concrete and repair with bed and bank treatment | \$138,000 |

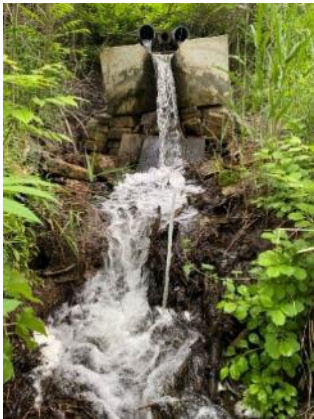
| Reach | Site No. | Photo | Issues | Priority |
|---|---|---|---|---|
| 4 | 4-1 | | <p>Large drop at pond outlet.</p> <p>Feature Type: Existing In-Channel Structures (E)</p> | Monitor/Level 3<br>Priority (5 – 10 years) |

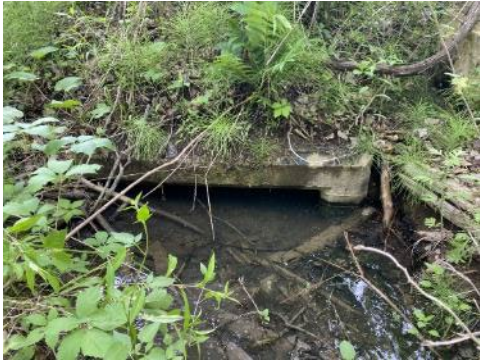
| Reach | Site No. | Photo | Issues | Priority |
|---|---|---|---|---|
| 4 | 4-2 | | <p>Culvert at base of embankment of St Paul Avenue backed up and silted in.</p> <p>Feature Type: Crossings (C)</p> | Monitor/Level 2<br>Priority (0 – 5 years) |

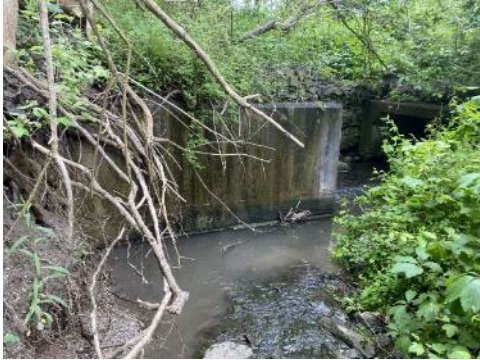
| Reach | Site No. | Photo | Issues | Priority |
|---|---|---|---|---|
| 4 | 4-3 | | Concrete culvert outlet below Highway 405 undermined and erosion of embankment due to flow from incoming drainage channel.<br><br>Feature Type: Crossings (C) | Monitor/Level 1 Priority (Immediate restoration) |

| Reach | Site No. | Level / Category | Recommended Treatment | Cost |
|---|---|---|---|---|
| 4 | 4-3 | 1 (C) | Repair valley wall scour to protect culvert and road | \$66,000 |

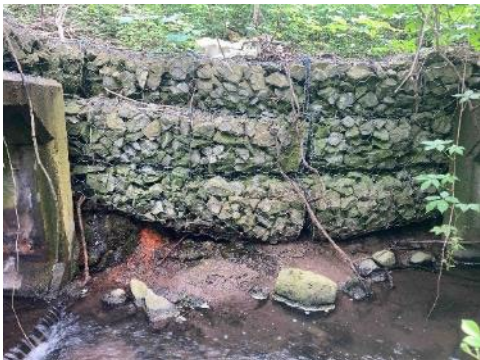
| Reach | Site No. | Photo | Issues | Priority |
|---|---|---|---|---|
| 4 | 4-4 | | Undermined gabion baskets between the culvert outlet under Highway 405 and culvert inlet under Townline Road.<br><br>Feature Type: Existing In-Channel Structures (E) | Monitor/Level 1 Priority (Immediate restoration) |

| Reach | Site No. | Level / Category | Recommended Treatment | Cost |
|---|---|---|---|---|
| 4 | 4-4 | 1 (E) | Protect toe of gabion baskets or replace gabion baskets | \$126,000 |

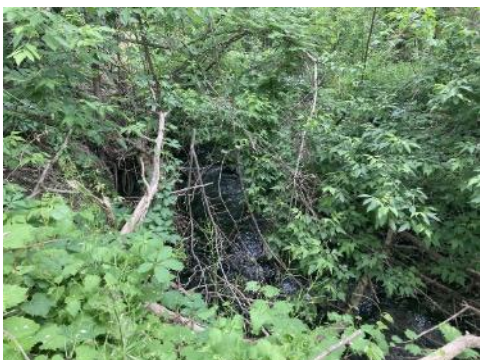
| Reach | Site No. | Photo | Issues | Priority |
|---|---|---|---|---|
| 5 | 5-1 | | Steep eroded left bank in close proximity to private property<br><br>Property (P) | Monitor/Level 2 Priority (0 – 5 years) |

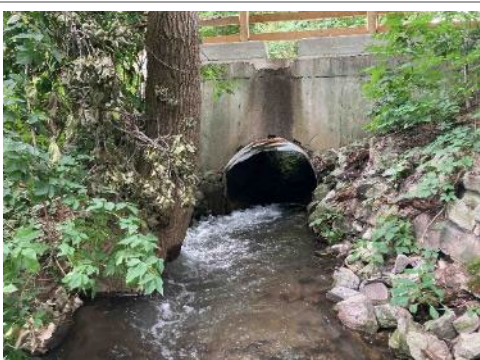
| Reach | Site No. | Photo | Issues | Priority |
|---|---|---|---|---|
| 6 | 6-1 | | Flow from culvert outlet directed towards tree on right bank. Stone bank protection on left bank falling into channel.<br><br>Feature Type: Property (P); Existing In-Channel Structures (E); Crossings (C) | Monitor/Level 3 Priority (5 – 10 years) |

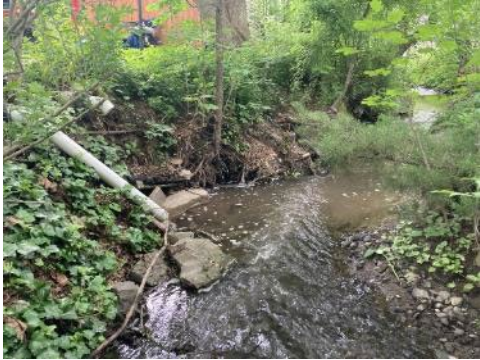
| Reach | Site No. | Photo | Issues | Priority |
|---|---|---|---|---|
| 6 | 6-2 | | Narrow channel corridor between properties within Creekside Senior Estates. Outer bank erosion and scour pool.<br><br>Feature Type: Property (P) | Monitor/Level 2<br>Priority (0 – 5 years) |

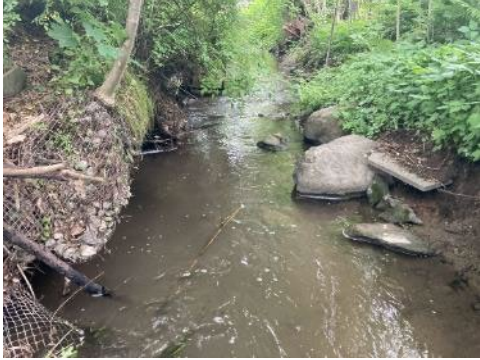
| Reach | Site No. | Photo | Issues | Priority |
|---|---|---|---|---|
| 6 | 6-3 | | Slumping, undermined gabions and erosion of private property<br><br>Feature Type: Existing In-Channel Structures (E); Property (P) | Monitor/Level 1<br>Priority (Immediate restoration) |

| Reach | Site No. | Level / Category | Recommended Treatment | Cost |
|---|---|---|---|---|
| 6 | 6-3 | 1 (P) (E) | Remove failed gabion baskets and replace with bed and bank protection | \$75,000 |

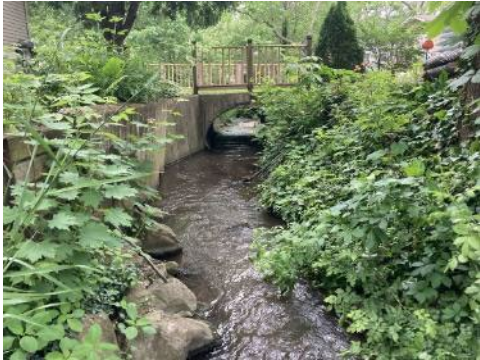
| Reach | Site No. | Photo | Issues | Priority |
|---|---|---|---|---|
| 6 | 6-4 | | Leaning concrete retaining wall upstream of road crossing in Creekside Senior Estates<br><br>Feature Type: Crossings (C); Existing In-Channel Structure (E) | Monitor/Level 3<br>Priority (5 – 10 years) |

| Reach | Site No. | Level / Category | Recommended Treatment | Cost |
|---|---|---|---|---|
| 6 | 6-4 | 3 (C) (E) | Replace leaning concrete wall with armourstone retaining wall | \$84,000 |

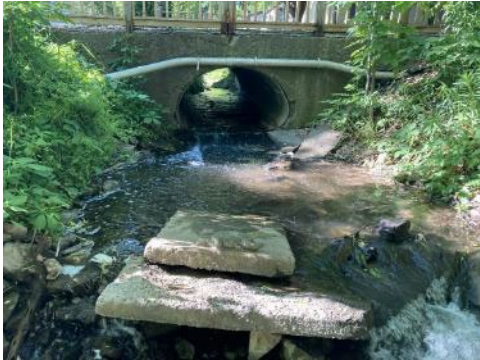
| Reach | Site No. | Photo | Issues | Priority |
|---|---|---|---|---|
| 6 | 6-5 | | Failing concrete apron downstream of culvert outlet under road crossing in Creekside Senior Estates<br><br>Feature Type: Crossings (C); Existing In-Channel Structure (E) | Monitor/Level 3<br>Priority (5 – 10 years) |

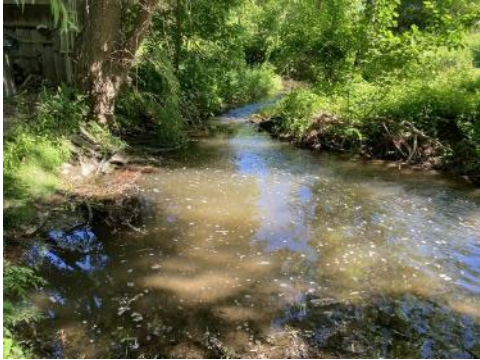
| Reach | Site No. | Photo | Issues | Priority |
|---|---|---|---|---|
| 7 | 7-1 | | Channel widening and basal scour along left bank in close proximity to private property (shed).<br><br>Feature Type: Property (P) | Monitor/Level 3<br>Priority (5- 10 years) |

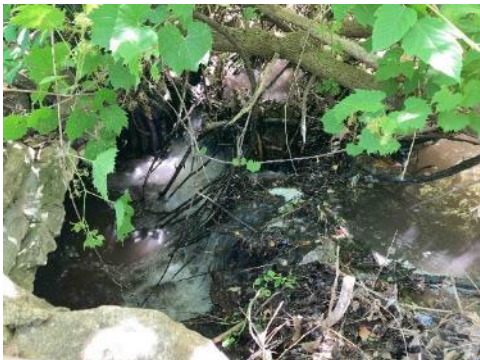
| Reach | Site No. | Photo | Issues | Priority |
|---|---|---|---|---|
| 7 | 7-2 | | Knickpoint and debris accumulation upstream of culvert inlet at private driveway/road crossing.<br><br>Feature Type: Crossings (C); Property (P) | Monitor/Level 2<br>Priority (0 – 5 years) |

| Reach | Site No. | Level / Category | Recommended Treatment | Cost |
|---|---|---|---|---|
| 7 | 7-2 | 2 (P) (C) | Remove debris and repair bed and bank | \$42,000 |

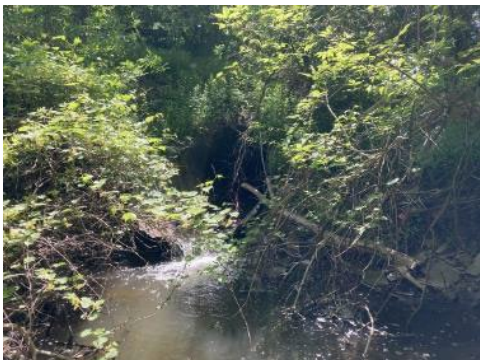
| Reach | Site No. | Photo | Issues | Priority |
|---|---|---|---|---|
| 8 | 8-1 | | Culvert outlet at York Road crossing elevated with downstream scour pool.<br><br>Feature Type: Crossings (C) | Monitor/Level 3<br>Priority (5- 10 years) |

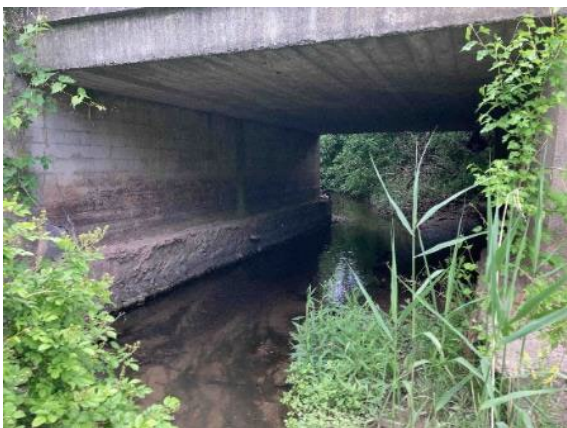
| Reach | Site No. | Photo | Issues | Priority |
|---|---|---|---|---|
| 10 | 10-1 | | Line 9 bridge footings exposed.<br><br>Feature Type: Crossings (C) | Monitor/Level 2<br>Priority (0 – 5 years).<br>Depth of footings should be reviewed. |

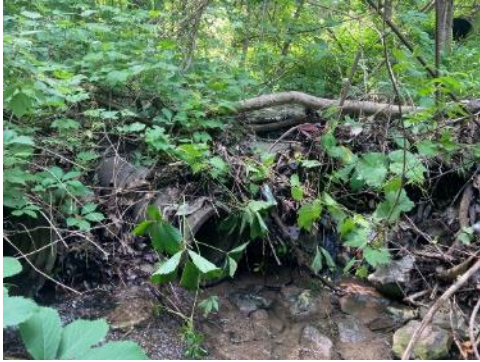
| Reach | Site No. | Photo | Opportunities for Restoration |
|---|---|---|---|
| 1 | 1-1R | | Debris jam with culvert debris in channel. Remove debris. |

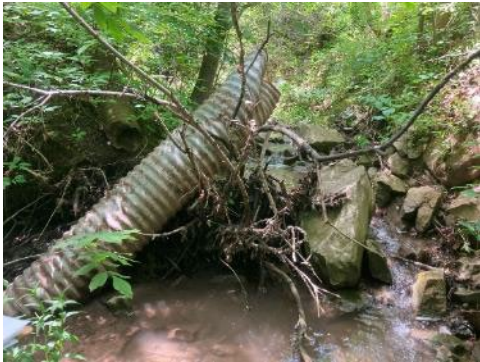
| Reach | Site No. | Photo | Opportunities for Restoration |
|---|---|---|---|
| 2 | 2-1R | | Debris jam with culvert debris in channel. Remove debris. |

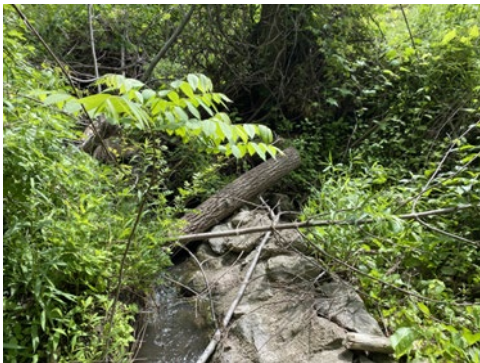
| Reach | Site No. | Photo | Opportunities for Restoration |
|---|---|---|---|
| 3 | 3-1R | | Remove concrete channel lining throughout Reach 3 and replace with hydraulically sized natural bed material. This may not be practical given the steepness of this reach. |

| Reach | Site No. | Recommended Treatment | Cost |
|---|---|---|---|
| 3 | 3-1R | Remove concrete and repair with bed and bank treatment | \$630,000 |

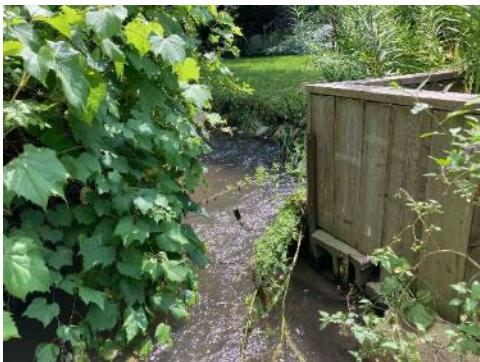
| Reach | Site No. | Photo | Opportunities for Restoration |
|---|---|---|---|
| 5 | 5-1R | | Remove wooden retaining wall built into creek and establish riparian buffer between the creek and mowed lawn. |

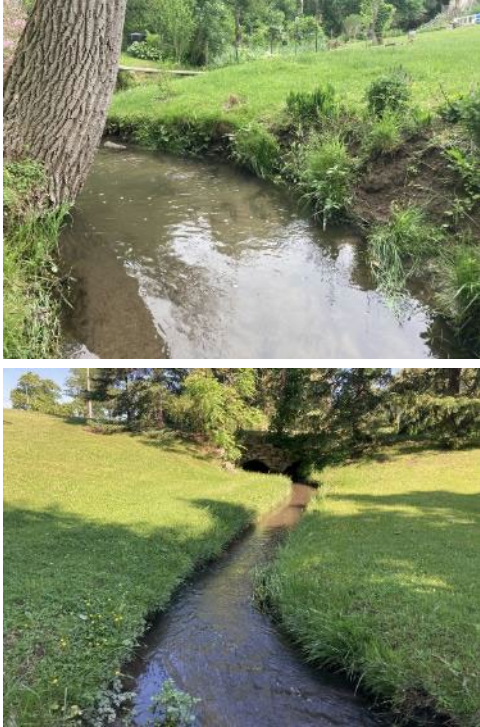
| Reach | Site No. | Photo | Opportunities for Restoration |
|---|---|---|---|
| 6 | 6-1R | | Increase riparian plantings and establish a riparian buffer between the creek and mowed lawns. |

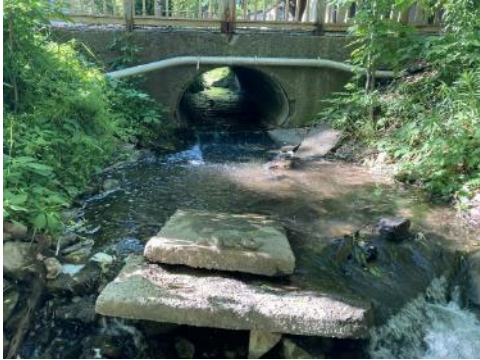
| Reach | Site No. | Photo | Opportunities for Restoration |
|---|---|---|---|
| 6 | 6-2R | | Remove concrete debris from channel and restore potential for fish passage. |

| Reach | Site No. | Recommended Treatment | Cost |
|---|---|---|---|
| 6 | 6-2R | Remove concrete and repair with bed and bank treatment | \$84,000 |

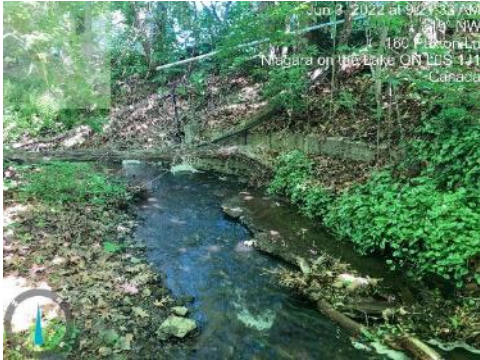
| Reach | Site No. | Photo | Opportunities for Restoration |
|---|---|---|---|
| 6 | 6-3R | | Remove concrete from bed of the channel and replace with natural substrate. |

| Reach | Site No. | Recommended Treatment | Cost |
|---|---|---|---|
| 6 | 6-3R | Remove concrete and replace with more natural bed material | \$91,000 |

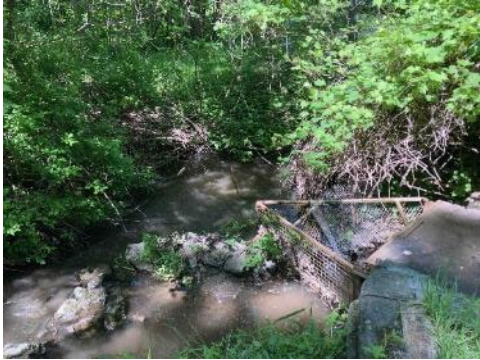
| Reach | Site No. | Photo | Opportunities for Restoration |
|---|---|---|---|
| 7 | 7-1R | | Remove structure if not providing any function and restore a more natural channel with potential for fish passage. |

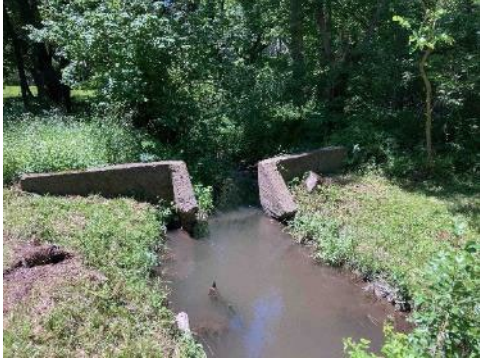
| Reach | Site No. | Photo | Opportunities for Restoration |
|---|---|---|---|
| 7 | 7-2R | | Remove concrete weir if not providing any function and restore a more natural channel with potential for fish passage. |

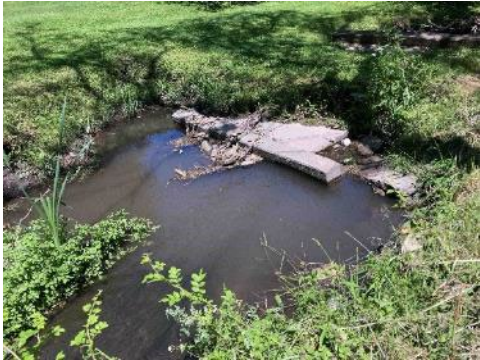
| Reach | Site No. | Photo | Opportunities for Restoration |
|---|---|---|---|
| 7 | 7-3R | | Remove failed concrete culvert and restore a more natural channel with potential for fish passage. |

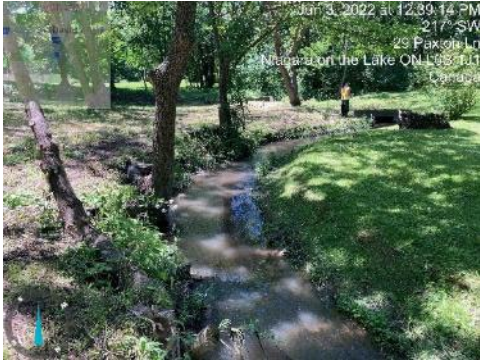
| Reach | Site No. | Photo | Opportunities for Restoration |
|---|---|---|---|
| 7 | 7-4R | | Increase riparian plantings and establish a riparian buffer between the creek and mowed lawns. |

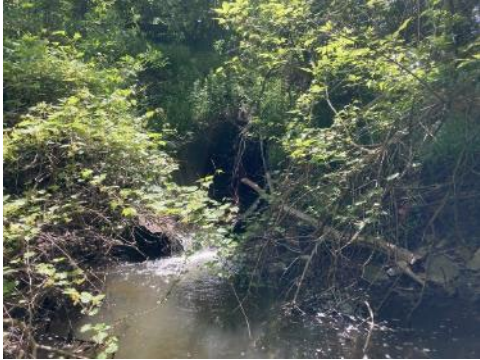
| Reach | Site No. | Photo | Opportunities for Restoration |
|---|---|---|---|
| 8 | 8-1R | | Perched culvert outlet at York Road crossing creating barrier for fish passage. Downstream channel bed elevation could be restored to provide the potential for fish passage. |

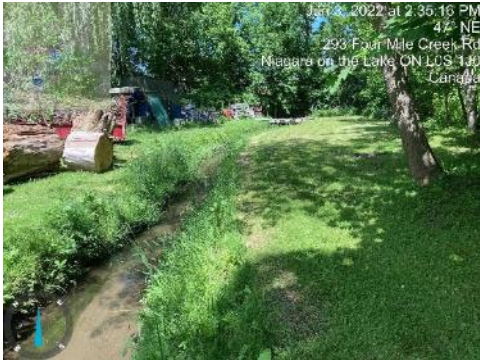
| Reach | Site No. | Photo | Opportunities for Restoration |
|---|---|---|---|
| 8 | 8-2R | | Increase riparian plantings and establish a riparian buffer between the creek and mowed lawns. |

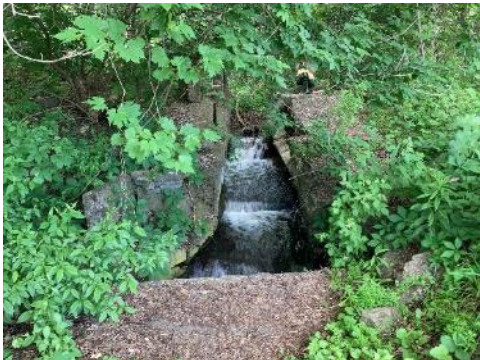
| Reach | Site No. | Photo | Opportunities for Restoration |
|---|---|---|---|
| 8 | 8-3R | | Remove concrete weir/structures and daylight creek if not providing any function. |

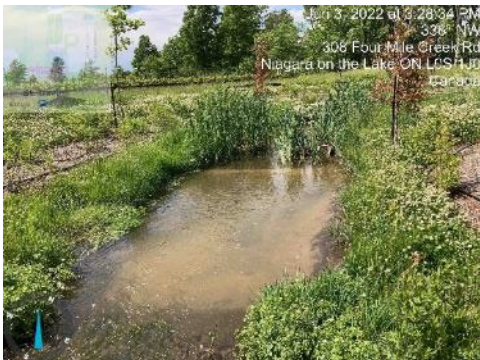
| Reach | Site No. | Photo | Opportunities for Restoration |
|---|---|---|---|
| 9 | 9-1R | | Pools in recently realigned reach downcut to till with no instream or riparian cover. Add substrate and cover to improve fish habitat. |

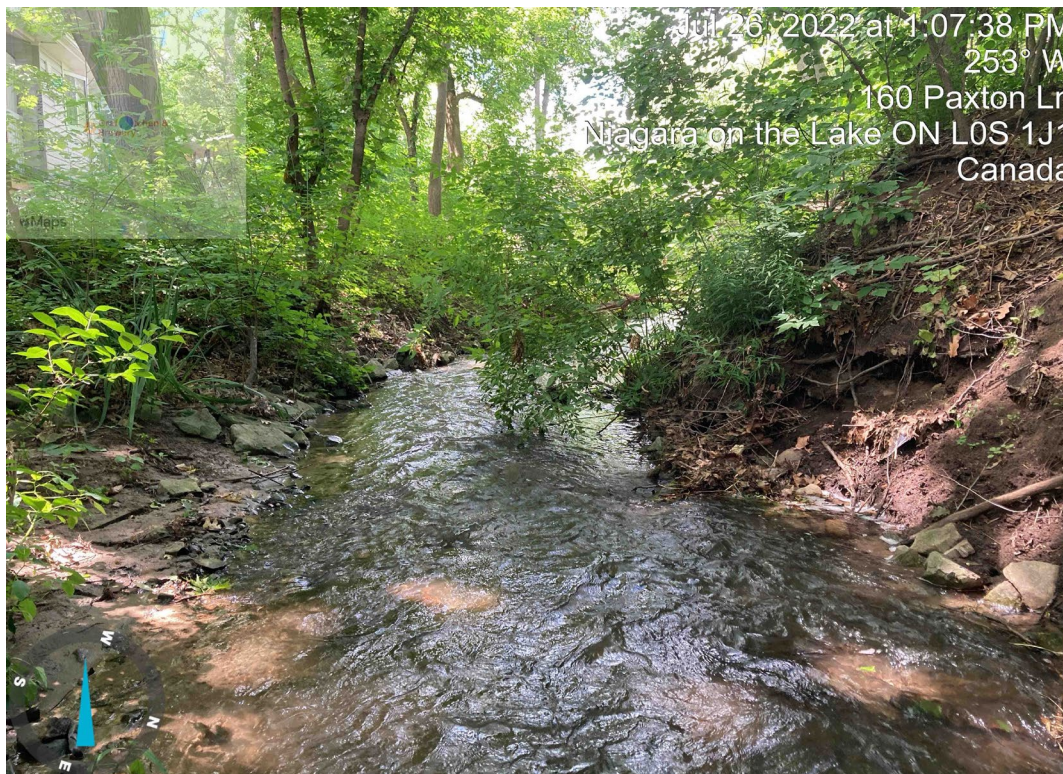
*Downstream view of cross section # 2*

***Well-defined, partially confined watercourse with narrow riparian zone. Narrow, meandering channel through Creekside Senior Estates. Predominantly riffle and run bed morphology. Steep banks comprised of sand with some silt/clay. Bed material consists of sand, gravel, and cobble. Bank protection measures such as retaining walls and rip rap lining the toe of slope. Signs of erosion on exposed banks.***
