# Lower Four Mile Creek Rapid Geomorphic Assessment

**AHYDTECH Geomorphic Ltd.**

**APRIL 2026**

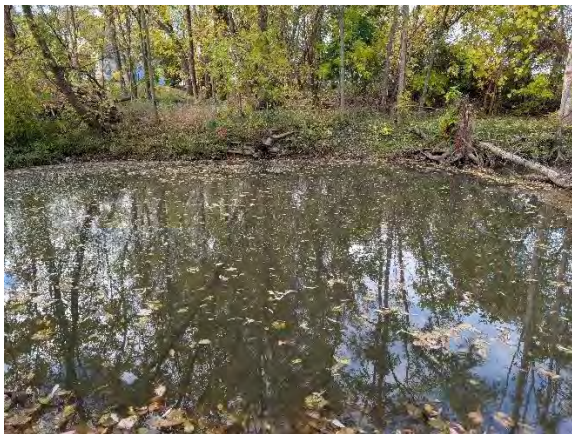
During reconnaissance, the creek was observed to contain numerous fallen and broken trees, exposed root systems, and significant in-channel woody debris accumulations. These features are indicative of ongoing bank erosion, toe scour, and localized channel instability in several reaches. In many locations, exposed roots and undercut banks suggest active lateral adjustment processes. Indicators of geomorphic adjustment, including bank undercutting, localized slumping, and erosion-prone banks, were identified along several reaches. These

*Figure 4-3: Broken Tree at the Bank*

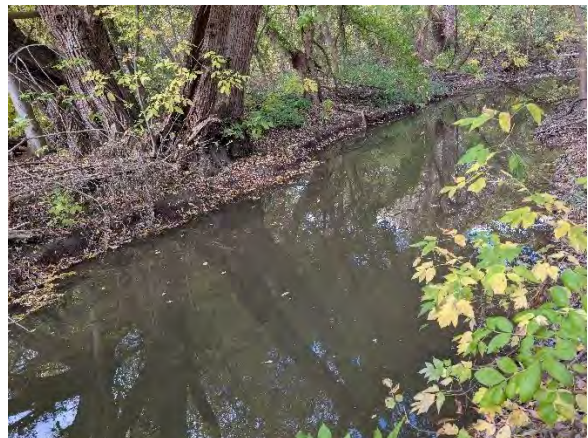
*Figure 4-4: In Channel Woody Debris*

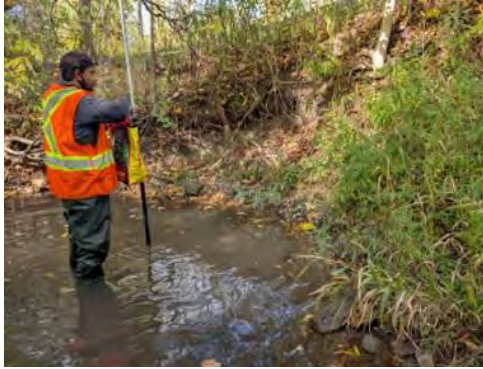
| Reach | Priority/<br>Severity | Image | Issues | Opportunities<br>for Restoration |
|---|---|---|---|---|
| Reach 01 | Level 2 | | Bank erosion accompanied by exposed root systems, contributing to ongoing bank instability. | Removal of obstructing debris and targeted vegetative reinforcement could help stabilize the affected section. |

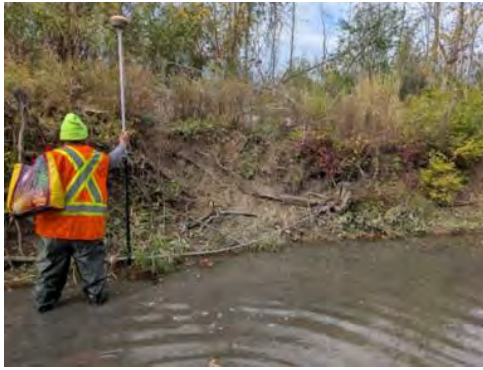
| Reach | Priority/<br>Severity | Image | Issues | Opportunities<br>for Restoration |
|---|---|---|---|---|
| Reach 01 | Level 2 | | Localized soil loss with exposed roots, suggesting moderate instability | Reinforcing the area with vegetation and supportive plantings is recommended to enhance bank stability. |

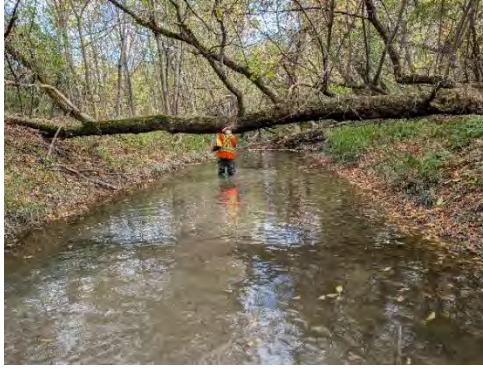
| Reach | Priority/<br>Severity | Image | Issues | Opportunities<br>for Restoration |
|---|---|---|---|---|
| Reach 01 | Level 5 | | A fallen tree creating minor disruption to the channel | Removal of the tree and incorporation of natural woody elements could support habitat and channel stability. |

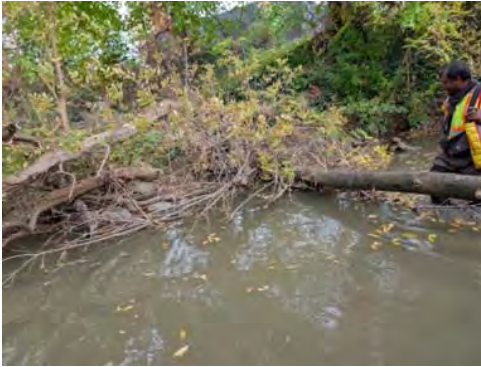
| Reach | Priority/<br>Severity | Image | Issues | Opportunities<br>for Restoration |
|---|---|---|---|---|
| Reach 03 | Level 4 | | Fallen tree, branches, and debris are present within the creek channel without noticeable bank erosion | Removal of obstructing material and integration of natural woody elements could enhance habitat and flow conditions. |

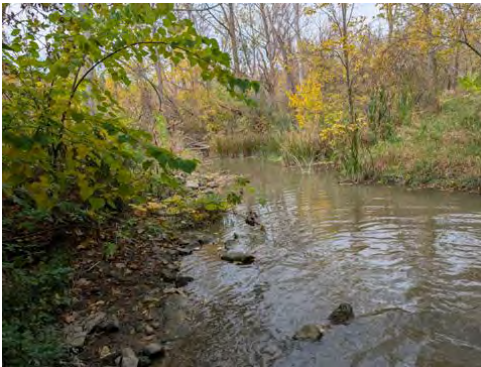
| Reach | Priority/<br>Severity | Image | Issues | Opportunities<br>for Restoration |
|---|---|---|---|---|
| Reach 04 | Level 5 | | Minor bank erosion observed due to localized exposure | Stabilizing the affected area with natural vegetation or structural support could help limit further deterioration. |

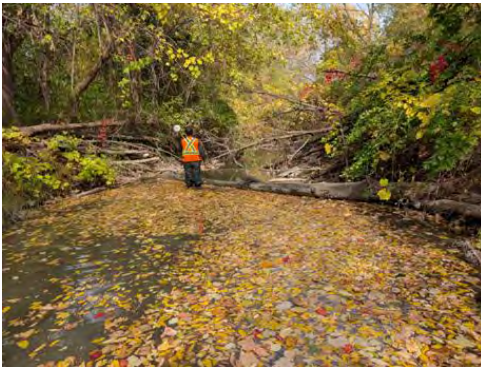
| Reach | Priority/<br>Severity | Image | Issues | Opportunities<br>for Restoration |
|---|---|---|---|---|
| Reach 04 | Level 4 | | Fallen trees with intense debris and branches | Removal of obstructive material followed by installation of natural structural elements could help stabilize the area. |

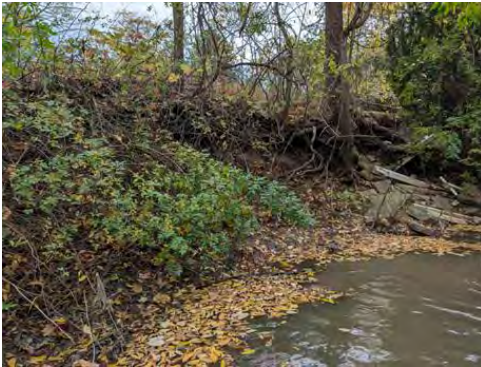
| Reach | Priority/<br>Severity | Image | Issues | Opportunities<br>for Restoration |
|---|---|---|---|---|
| Reach 04 | Level 2 | | Bank erosion associated with exposed root systems, contributing to localized instability | Stabilization through vegetative reinforcement and bioengineering measures is recommended. |

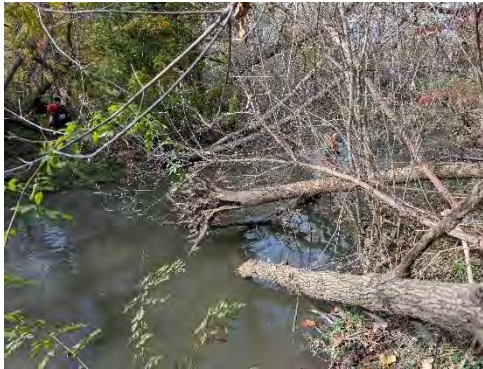
| Reach | Priority/<br>Severity | Image | Issues | Opportunities<br>for Restoration |
|---|---|---|---|---|
| Reach 05 | Level 4 | | Branches and uprooted trees along the channel margin, contributing to localized obstruction | Removal of unstable material and reinforcement with natural root structures could help stabilize the area. |

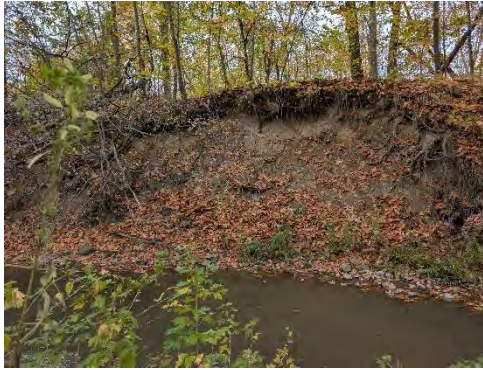
| Reach | Priority/<br>Severity | Image | Issues | Opportunities<br>for Restoration |
|---|---|---|---|---|
| Reach 05 | Level 3 | | Bank slump with localized soil loss and instability | Implementing vegetative reinforcement and bio-stabilization could help reduce further erosion. |

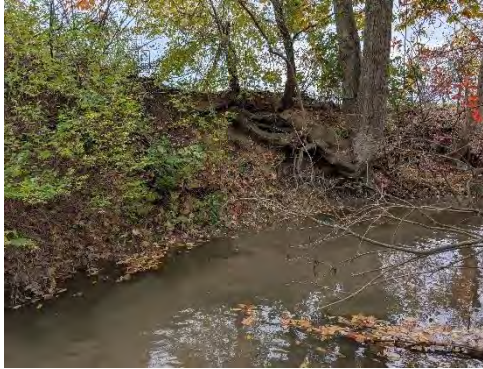
| Reach | Priority/<br>Severity | Image | Issues | Opportunities<br>for Restoration |
|---|---|---|---|---|
| Reach 05 | Level 2 | | Bank instability with exposed roots and partially fallen trees | Removal of obstructing debris followed by targeted vegetation and structural reinforcement is recommended to stabilize the slope. |

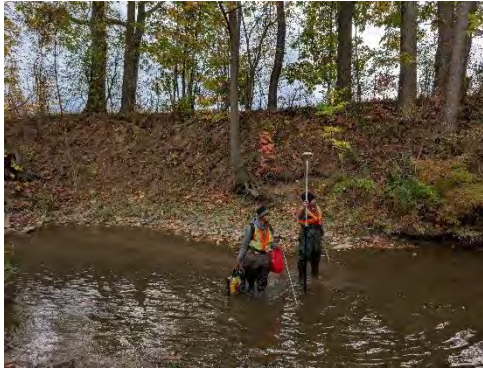
| Reach | Priority/<br>Severity | Image | Issues | Opportunities<br>for Restoration |
|---|---|---|---|---|
| Reach 05 | Level 2 | | Bank exhibiting significant erosion with exposed roots and standing trees | Removal of unstable soil and debris is recommended, followed by stabilization and vegetative reinforcement to limit further bank retreat. |

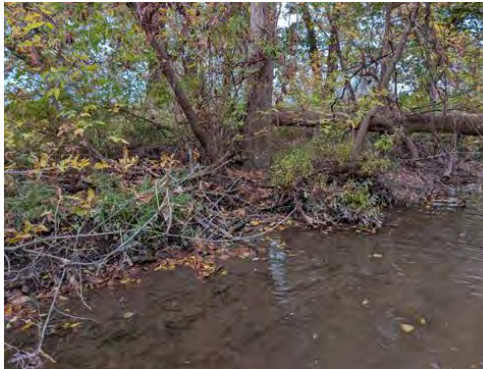
| Reach | Priority/<br>Severity | Image | Issues | Opportunities<br>for Restoration |
|---|---|---|---|---|
| Reach 06 | Level 2 | | Bank showing erosion with scattered fallen trees, exposed roots, and vegetation | Removal of obstructing debris is advised, followed by vegetative or structural measures to stabilize the bank. |

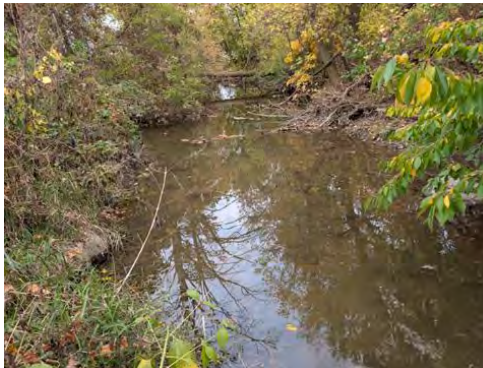
| Reach | Priority/<br>Severity | Image | Issues | Opportunities<br>for Restoration |
|---|---|---|---|---|
| Reach 06 | Level 3 | | Erosion observed on both banks, though subsequent dense vegetation provides some natural stabilization | Reinforcing vegetation and selective planting could further reduce ongoing erosion. |

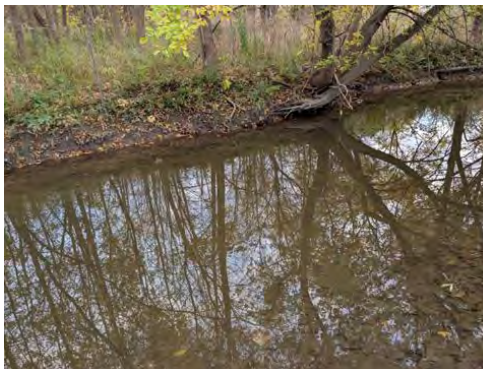
| Reach | Priority/<br>Severity | Image | Issues | Opportunities<br>for Restoration |
|---|---|---|---|---|
| Reach 06 | Level 3 | | Bank erosion associated with exposed roots of standing trees, indicating localized instability | Supplemental vegetation and natural stabilization measures could help reinforce the bank. |

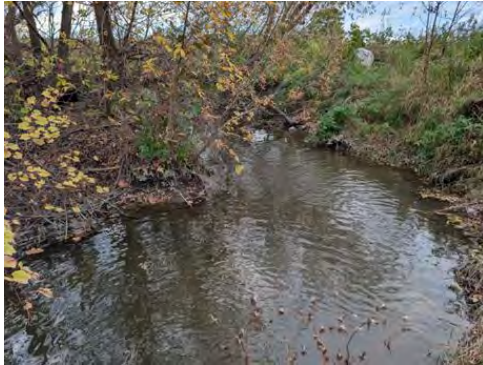
| Reach | Priority/<br>Severity | Image | Issues | Opportunities<br>for Restoration |
|---|---|---|---|---|
| <b>Reach 06</b> | Level 3 | | Minor erosion observed along both banks, suggesting early-stage instability | Natural vegetation and bio-stabilization measures could help reinforce these areas. |

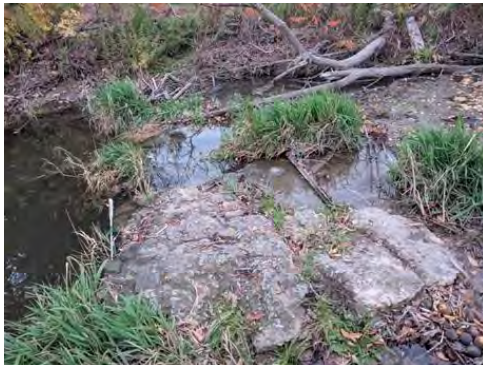
| Reach | Priority/<br>Severity | Image | Issues | Opportunities<br>for Restoration |
|---|---|---|---|---|
| <b>Reach 07</b> | Level 3 | | Branches present within the creek accompanied by minor bank erosion, indicating moderate instability | Targeted vegetation and natural structural measures could help stabilize the affected section. |

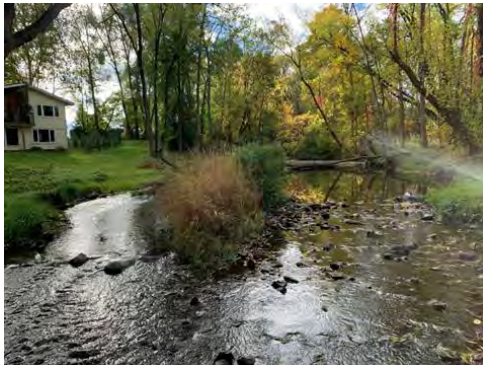
| Reach | Priority/<br>Severity | Image | Issues | Opportunities<br>for Restoration |
|---|---|---|---|---|
| <b>Reach 08</b> | Level 4 | | Minor bank erosion accompanied by a fallen tree, suggesting localized instability | Removal of debris and establishment of vegetative support could help restore stability. |

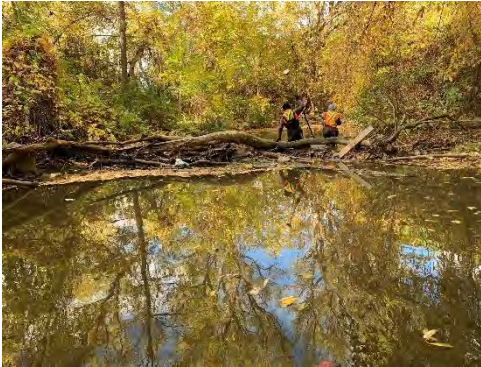
| Reach | Priority/<br>Severity | Image | Issues | Opportunities<br>for Restoration |
|---|---|---|---|---|
| Reach 08 | Level 5 | | Broken trees have fallen into the creek, contributing debris and minor flow disruption | Clearing the debris and encouraging natural vegetation growth along the banks may help maintain channel stability. |

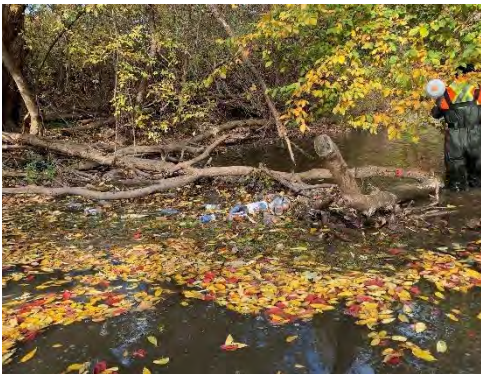
| Reach | Priority/<br>Severity | Image | Issues | Opportunities<br>for Restoration |
|---|---|---|---|---|
| Reach 08 | Level 5 | | Broken tree lies across the creek, accompanied by accumulated debris | Removal of the obstructing material and support for bank vegetation can help restore local channel |

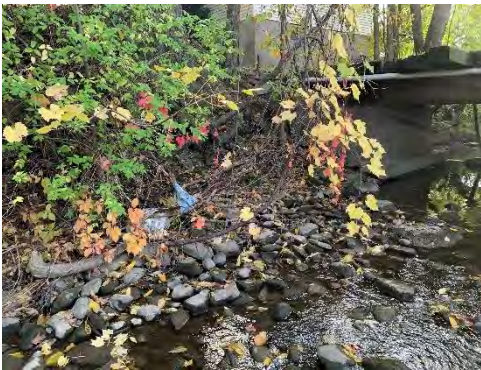
| Reach | Priority/<br>Severity | Image | Issues | Opportunities<br>for Restoration |
|---|---|---|---|---|
| Reach 09 | Level 5 | | Minor displacement of riprap observed due to long-term exposure and root growth | Consider gentle stabilization measures that integrate natural materials and vegetation. |

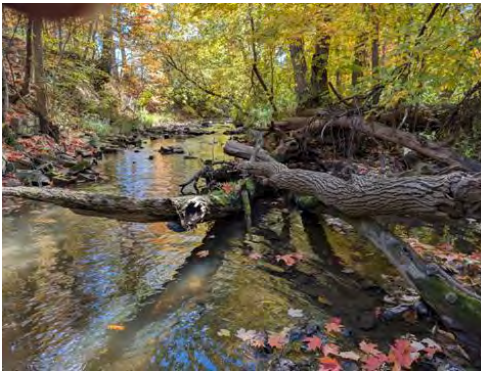
| Reach | Priority/<br>Severity | Image | Issues | Opportunities<br>for Restoration |
|---|---|---|---|---|
| Reach 10 | Level 1 | | Significant bank erosion accompanied by fallen trees and scattered branches in the creek | Immediate removal of debris is recommended, followed by stabilization measures to address ongoing bank instability. |

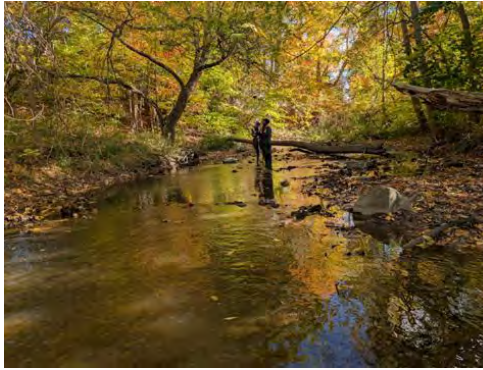
| Reach | Priority/<br>Severity | Image | Issues | Opportunities<br>for Restoration |
|---|---|---|---|---|
| Reach 10 | Level 4 | | Fallen tree with minor soil loss along the bank | Removal of the tree is advised, followed by vegetation-based stabilization to support gradual bank recovery. |

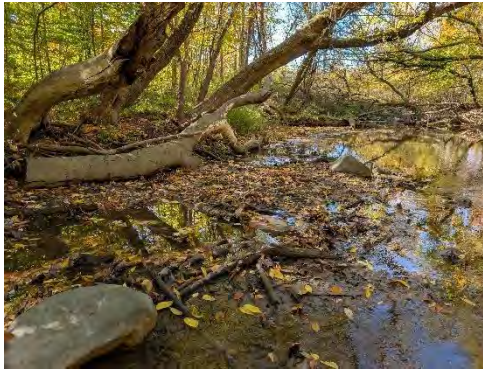
| Reach | Priority/<br>Severity | Image | Issues | Opportunities<br>for Restoration |
|---|---|---|---|---|
| Reach 10 | Level 5 | | Several broken and fallen trees with accumulated debris | Removal of obstructing material is suggested, complemented by low-impact natural habitat or stabilization features. |

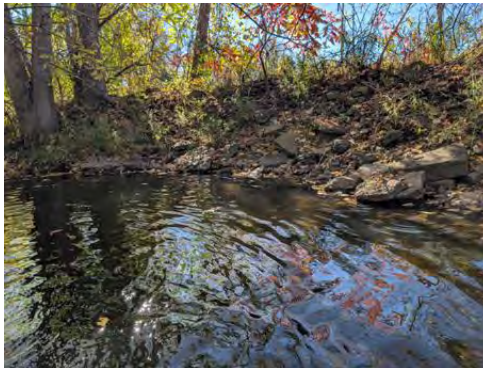
| Reach | Priority/<br>Severity | Image | Issues | Opportunities<br>for Restoration |
|---|---|---|---|---|
| Reach 11 | Level 5 | | Minor bank erosion observed | maintain natural stabilization and allow for gradual vegetation recovery. |

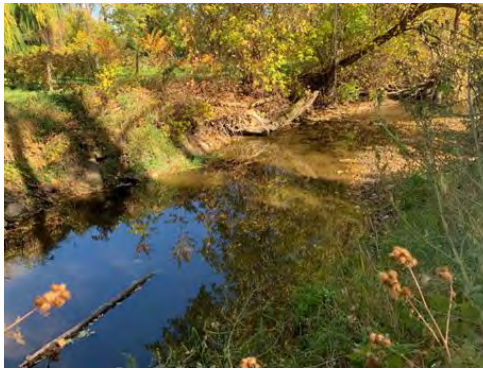
| Reach | Priority/<br>Severity | Image | Issues | Opportunities<br>for Restoration |
|---|---|---|---|---|
| Reach 11 | Level 2 | | Bank erosion with broken and fallen tree observed | Removal of obstructing debris and reinforcement with vegetation is recommended. |

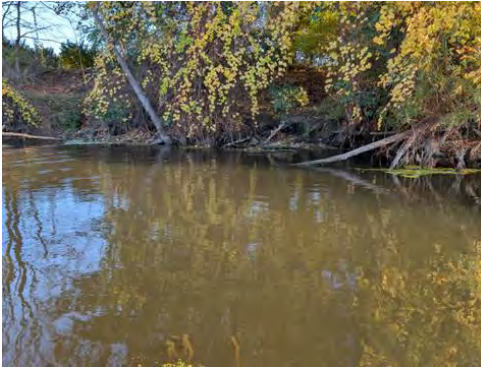
| Reach | Priority/<br>Severity | Image | Issues | Opportunities<br>for Restoration |
|---|---|---|---|---|
| Reach 12 | Level 5 | | Fallen trees observed along the creek bank | Clearing the debris. |

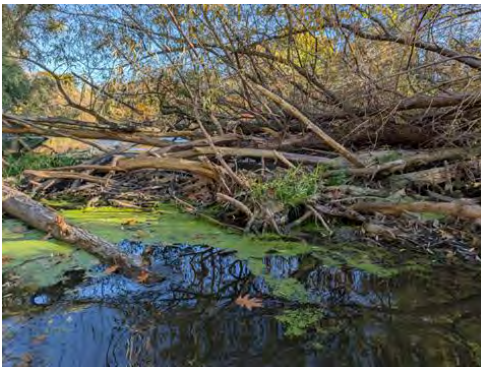
| Reach | Priority/<br>Severity | Image | Issues | Opportunities<br>for Restoration |
|---|---|---|---|---|
| Reach 12 | Level 2 | | Bank erosion with uprooted and broken trees and exposed roots | Removal of unstable debris and reinforcement with vegetation is recommended. |

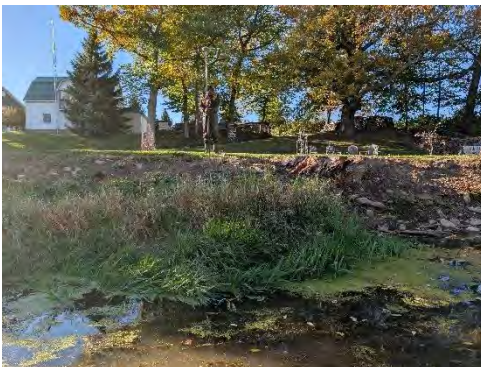
| Reach | Priority/<br>Severity | Image | Issues | Opportunities<br>for Restoration |
|---|---|---|---|---|
| Reach 12 | Level 2 | | Severe bank and soil erosion with exposed bank face | Immediate stabilization and protective intervention are recommended. |

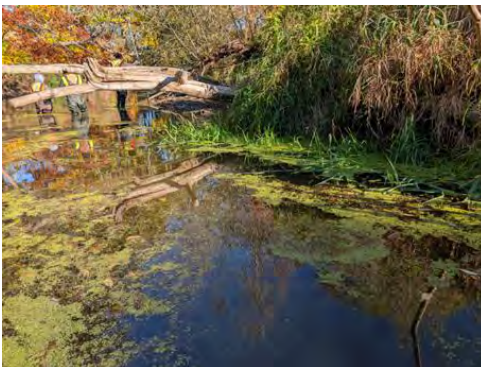
| Reach | Priority/<br>Severity | Image | Issues | Opportunities<br>for Restoration |
|---|---|---|---|---|
| Reach 12 | Level 3 | | Broken tree within the creek with minor bank erosion | Removal of debris and localized stabilization measures are recommended. |

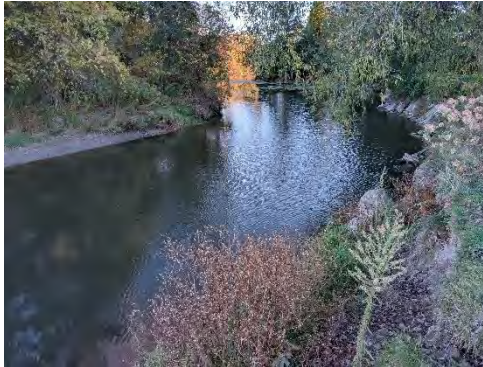
| Reach | Priority/<br>Severity | Image | Issues | Opportunities<br>for Restoration |
|---|---|---|---|---|
| Reach 12 | Level 3 | | Creek widening with minor visible bank erosion | targeted vegetation or natural stabilization measures could help reduce further lateral adjustment. |
