# OSWEGO CREEK FLOODPLAIN MAPPING

## HYDRAULIC REPORT

JANUARY 17, 2025

PROJECT 22-925

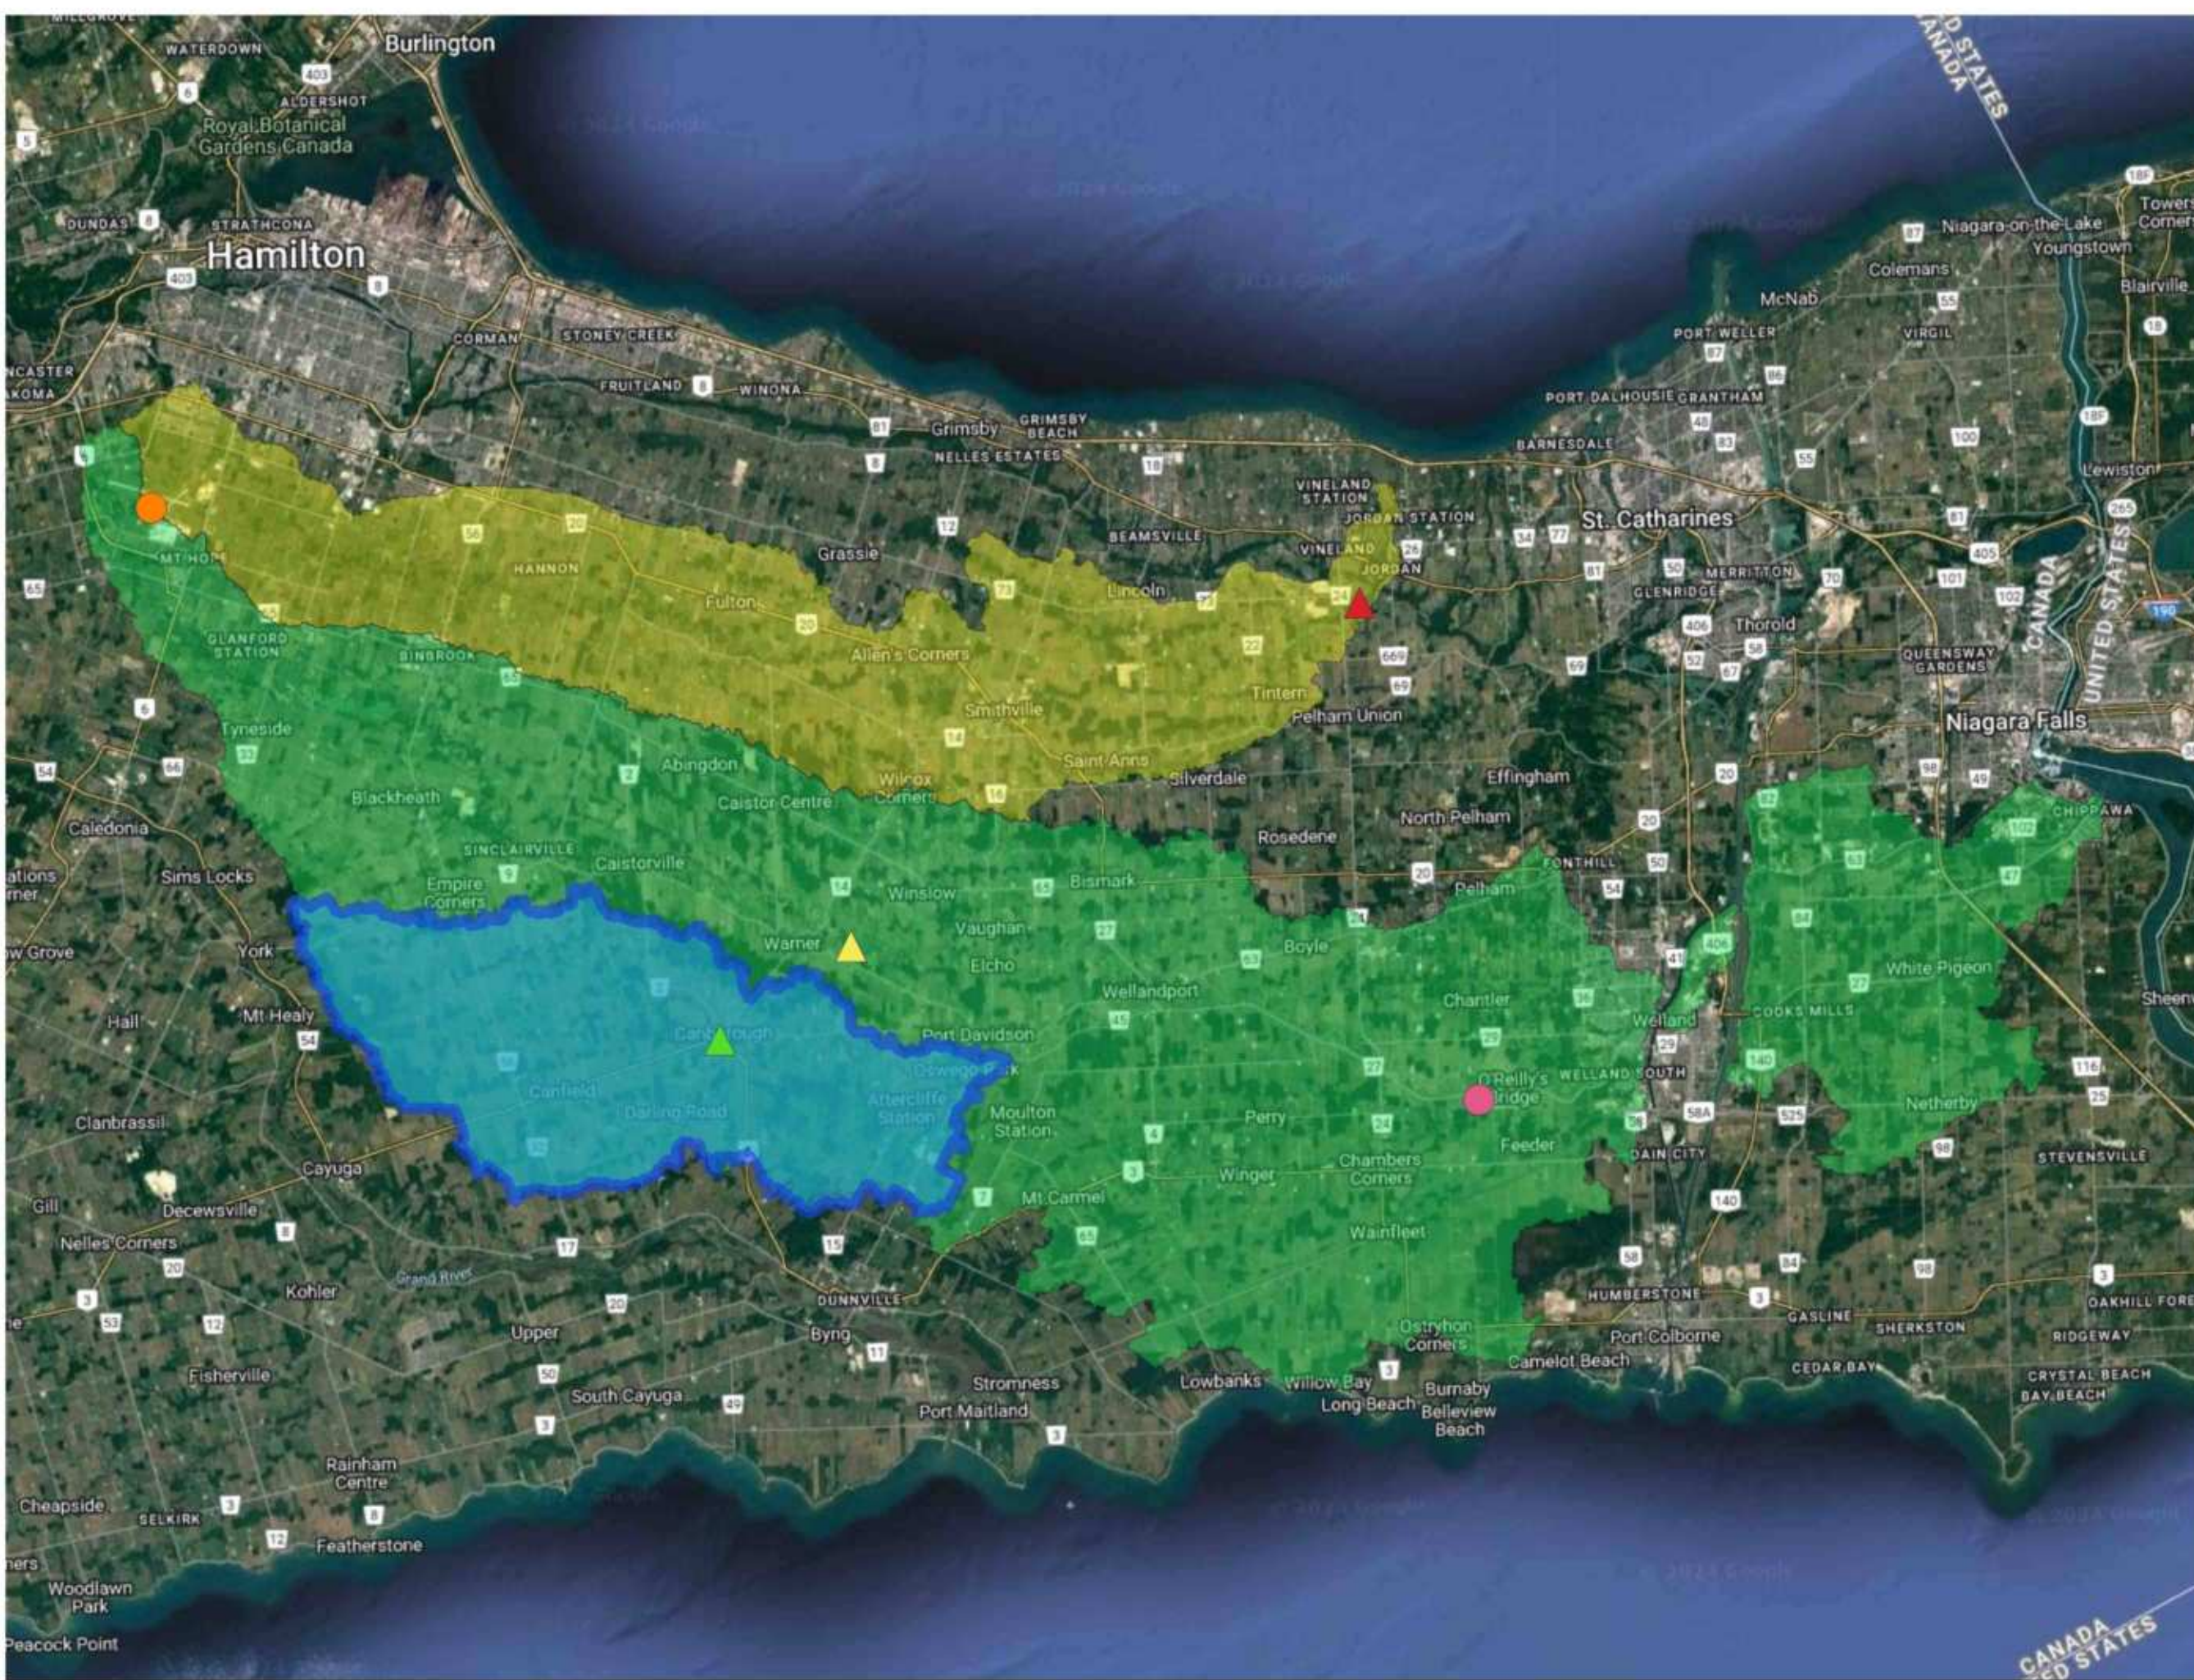
**Figure 1.1:**  
Oswego Creek, Welland  
River, and Twenty Mile  
Creek Watershed Map  
Oswego Creek  
Floodplain Mapping  
Project #: 22-925

The study area consists of the entire Oswego Creek watershed and is located in the southeastern portion of Haldimand County. Oswego Creek is a subwatershed of the Welland River watershed and has a drainage area of 187 square kilometers (km<sup>2</sup>). This represents 19% of the Welland River watershed, see **Figure 1.1**.

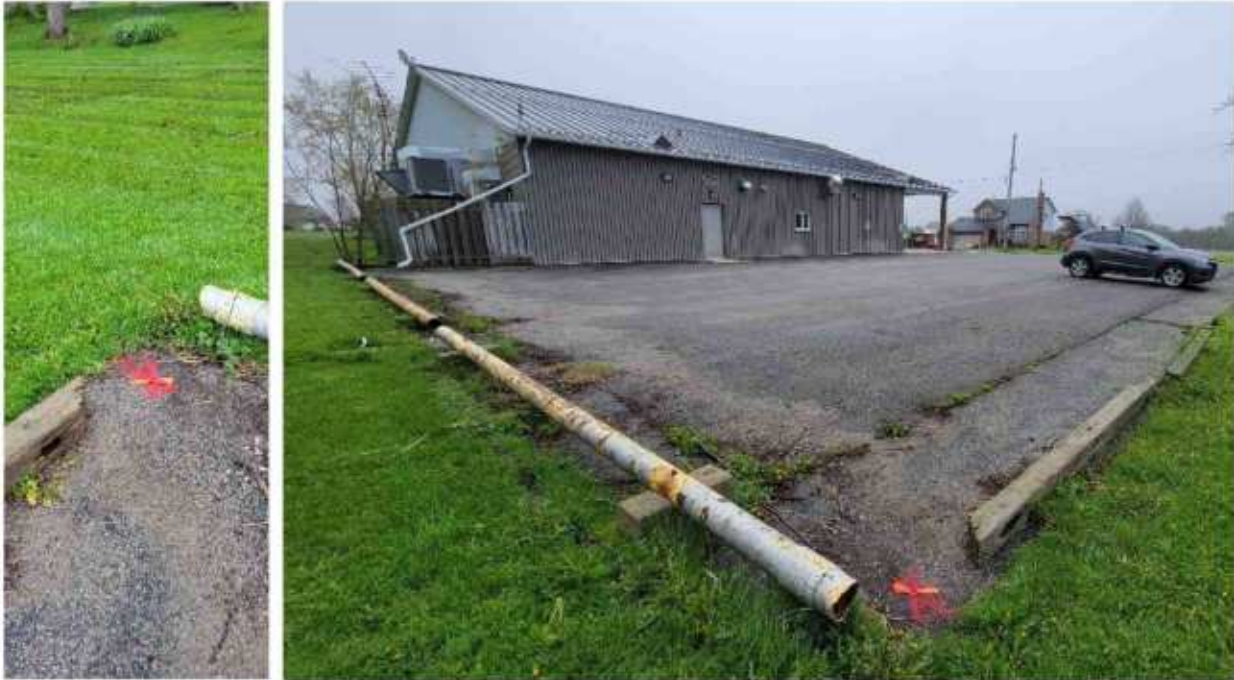
**FIGURE 2.1: BENCHMARK SETUP AT NORTHWEST CORNER OF THE CANBORO COMMUNITY CENTRE PARKING LOT**

Equipment used for the topographic survey included a Trimble R2 RTK Rover GPS with +/-1cm accuracy under a clear signal. To monitor the consistency of the equipment, a survey point of a benchmark was taken at the northwest corner of the Canboro Community Centre Parking Lot each day at the same time before visiting any sites, see **Figure 2.1**.

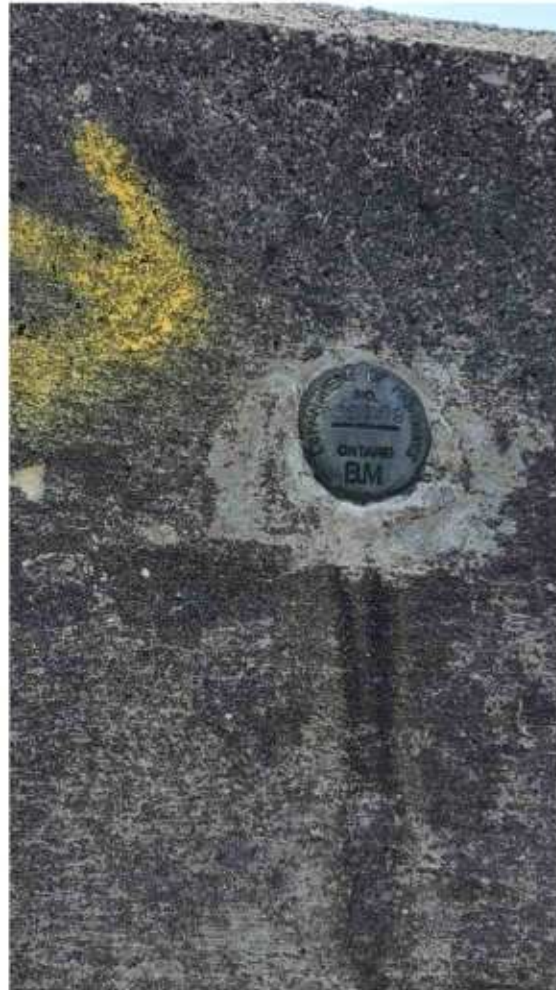
**FIGURE 2.2: MNR BENCHMARK 00819698351**

This benchmark survey point was used as the control point for the survey for the entire day. The consistency proved to be within 7 centimetres (cm) over the course of the entire surveying period. In addition to the local benchmark, a permanent Ontario Ministry of Natural Resources and Forestry (MNR) benchmark was surveyed and compared to the published elevations. See **Figure 2.2** for a photograph of the benchmark and see **Table 2.2** for the elevation comparison.

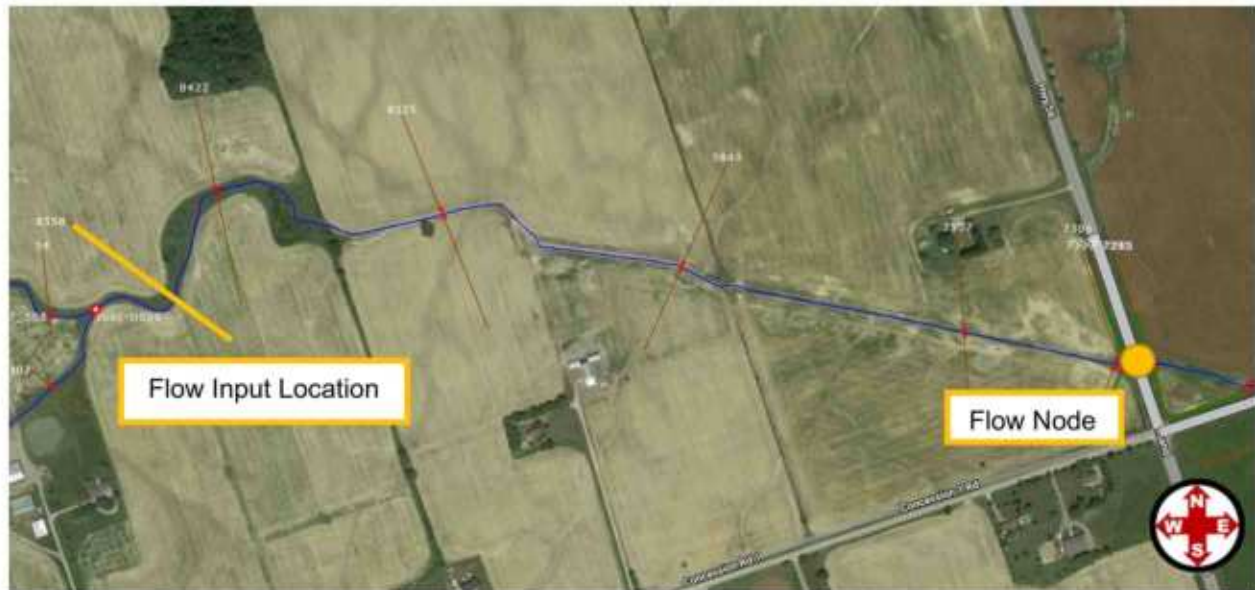
FIGURE 4.1: INCORPORATION OF FLOWS INTO HYDRAULIC MODEL

Peak flows determined by the PCSWMM hydrologic model were input directly into GeoHEC-RAS at select locations along each reach. A new flow was added where there was a significant flow change; flow changes would occur due to the addition of more drainage area. While all flow information for the 50-year, 100-year and 200-year design storms were included, the Regulatory floodline is defined by the 100-year storm. In all instances, flows recorded at a downstream point of interest would be inserted through the upstream section of the reach. For example, in **Figure 4.1**, flows derived at the road crossing 7306 would be inserted through the reach at cross section 8558. Flows at points of confluence between major reaches are incorporated directly at the point of confluence, as it would not be appropriate to convey flows at point of confluence further upstream.

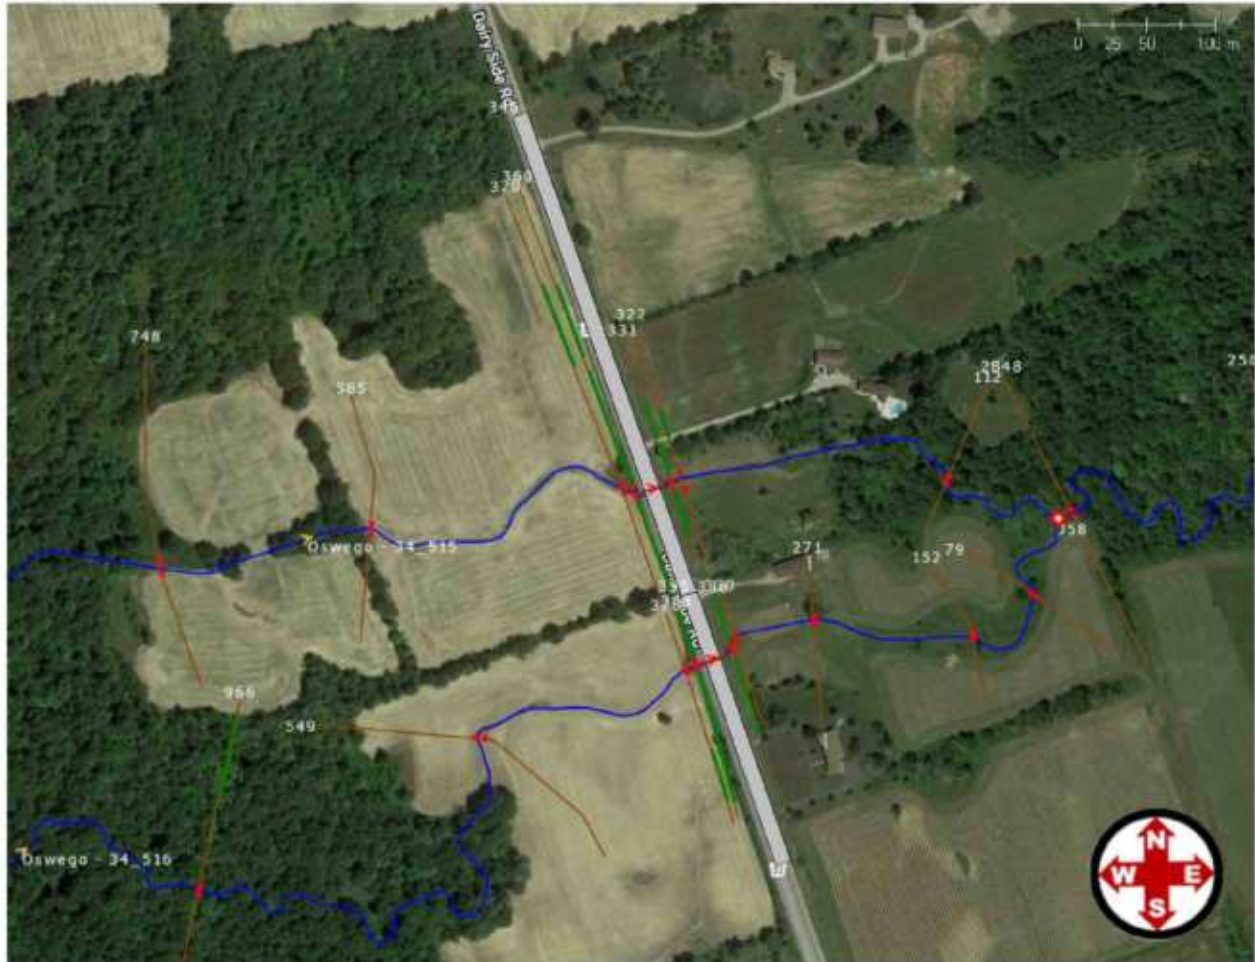
Reach 34\_515 and Reach 34\_516 run relatively parallel in a west to east direction and cross Dairy Side Road. Reach 34\_515 has a 600mm diameter circular CSP culvert at crossing 346 while Reach 34\_516 has a 2.1m x 1.5m concrete box culvert at crossing 355. **Figure 4.5** shows the location and configuration of the two reaches and crossings.

**FIGURE 4.5: CONFIGURATION OF REACH 34\_515 AND 34\_516**

In the initial run of the model, it was found that the culvert at crossing 345 of Reach 34\_515 causes backwater and flows spill into the floodplain of Reach 34\_516. At the two crossings, it was found that the flood elevation associated with Reach 34\_515 was significantly higher than at Reach 34\_516. As such, it can be concluded that in reality, a portion of the flows from Reach 34\_515 will be conveyed through the crossing at Reach 34\_516; both of the subject reaches would have similar flood elevations when the floodplains merge.

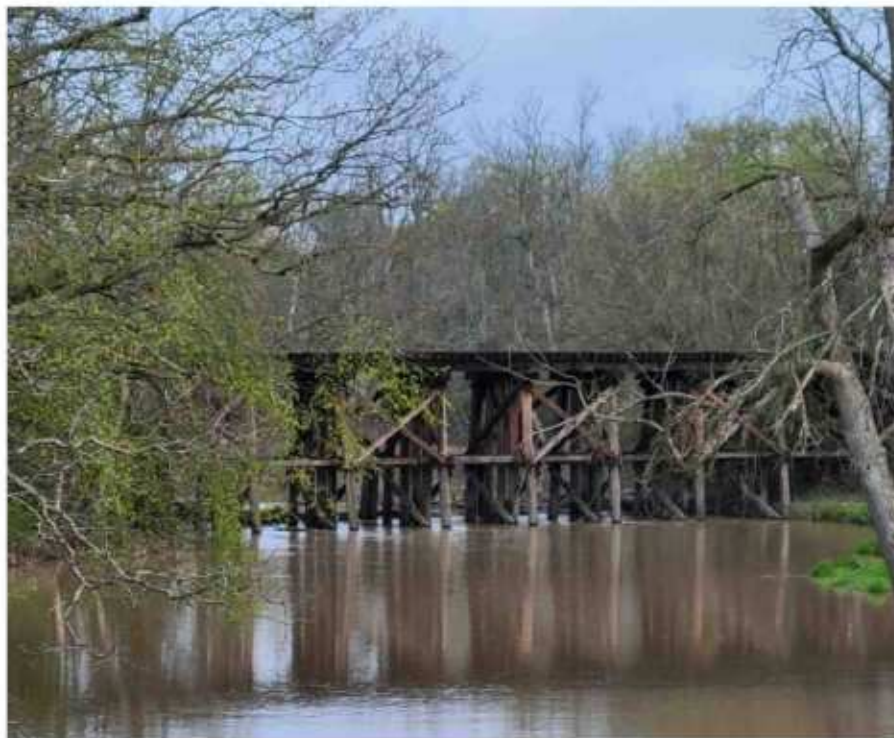
The trestle bridge is part of Reach 34\_100 and has a crossing ID of 2075. **Figure 4.6** Error! Reference source not found. shows the wooden trestle bridge.

FIGURE 4.6: WOODEN TRESTLE BRIDGE

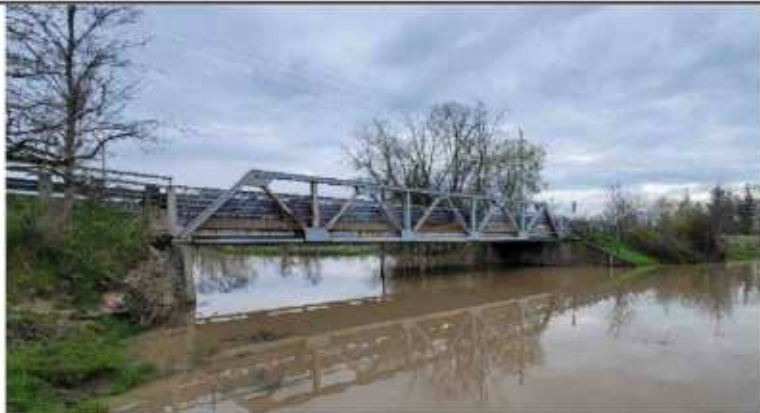
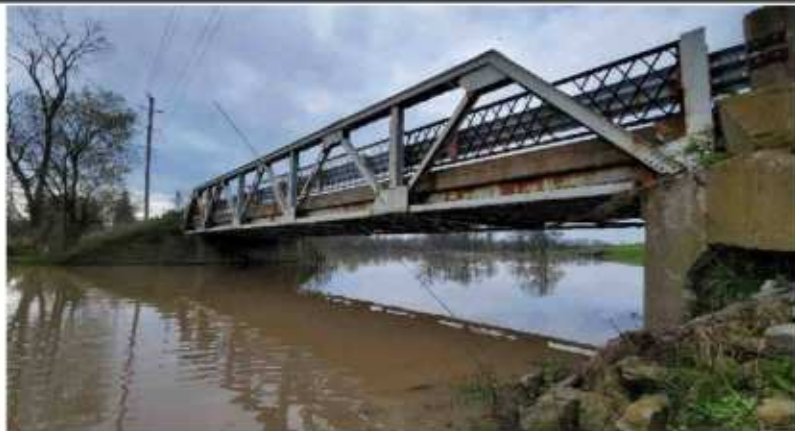
| <b>Additional Notes/Notable Obstructions:</b> | invert elevations measured from survey point d1-3.86, d2-4.16, d3-4.18, d4-4.06, d5- 4.05, d6-3.93, d7-4.15, d8-4.42, d9-4.07, d10-3.656 |

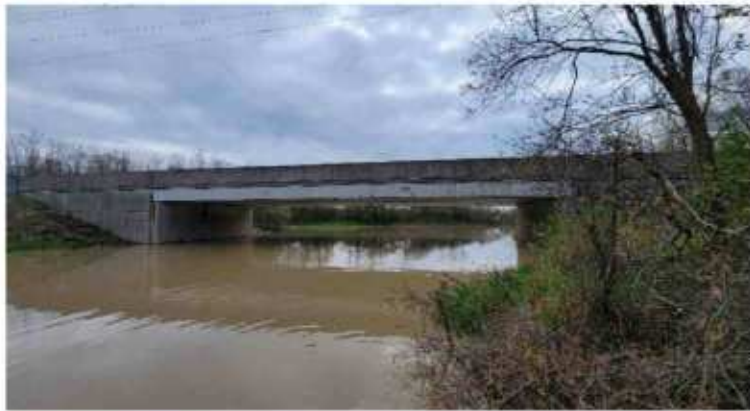
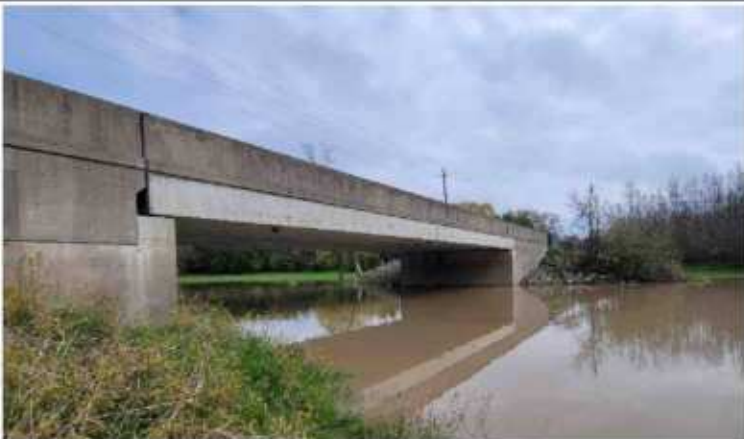
| <b>Additional Notes/Notable Obstructions:</b> | rise from we 2.88<br>invert measurement from top of barrier d1-5.95, d2-7.15, d3-6.7, d4-6.2, d5-6.9, d6-6.55 |

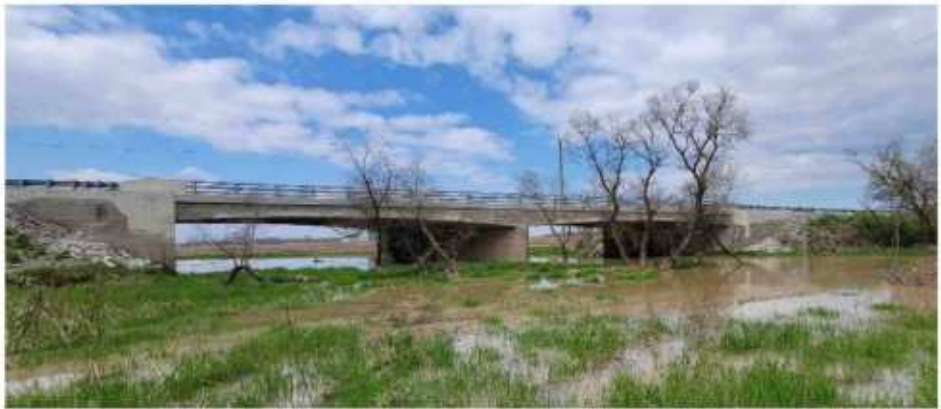
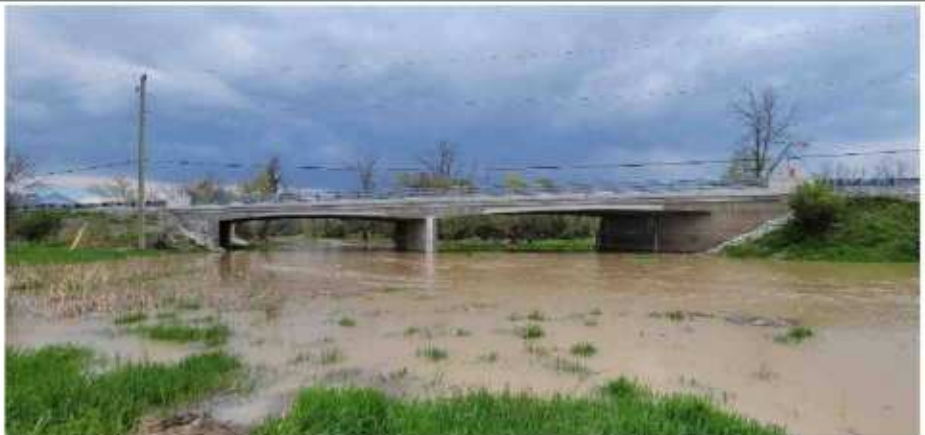
| <b>Additional Notes/Notable Obstructions:</b> | <p>measurement from guard rail deck d1-5.35, d2-5.27, d3-5.22, d4-6.2, d5-5.12, d6-6.10, d7-5.4, d8-6.45, d9-5.16</p> <p>no good as pipe extrudes -measurement taken from deck to obvert d1-1.77, d2-1.89, d5-1.73, d7-1.89, d8-1.83, d9-1.8</p> <p>arc measurements from WE left 3.07 centre 3.4 right 2.84</p> |

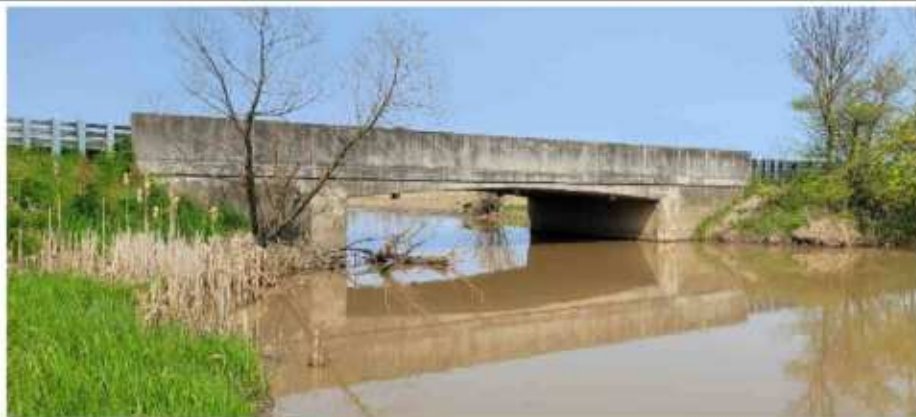
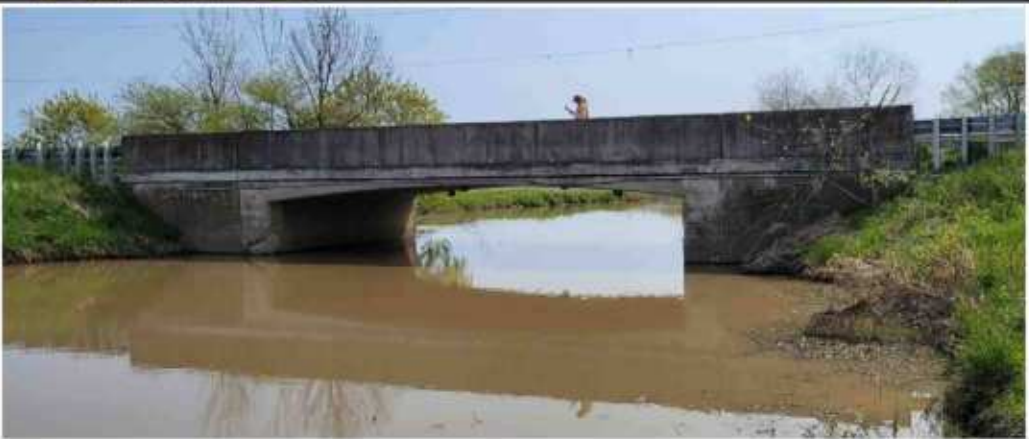
| <b>Additional Notes/Notable Obstructions:</b> | DS: D1 - measurement from road deck 3.18m, D2 - 3.31m, D3 - 3.16m<br>US: D4 - 3.28m, D5 - 3.47m, D6 - 3.5m<br>top of barrier ds 175.20, top of barrier us 175.21<br>us and ds elevations calculated from rpd measurement |

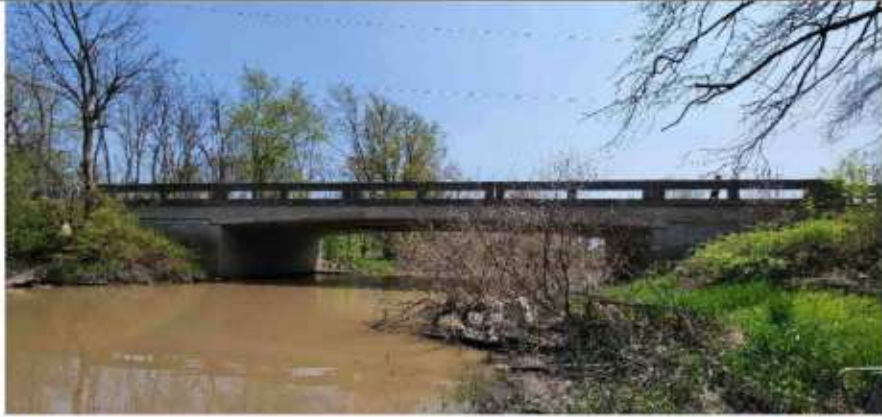
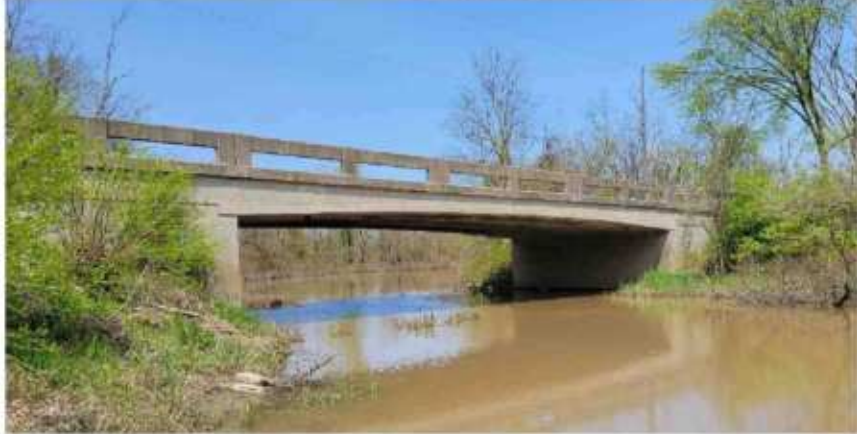
| <b>Additional Notes/Notable Obstructions:</b> | <p>Measurement from top of barrier D1-5.7m, D2-5.76m, D3-invert-5.9m, D4-5.8m<br/> D5-5.38m, D6-invert-5.54m, D7-5.72m, D8-5.6m<br/> Instream bush barrier on DS side<br/> Concrete road barrier over bridge, steel barrier on road</p> |

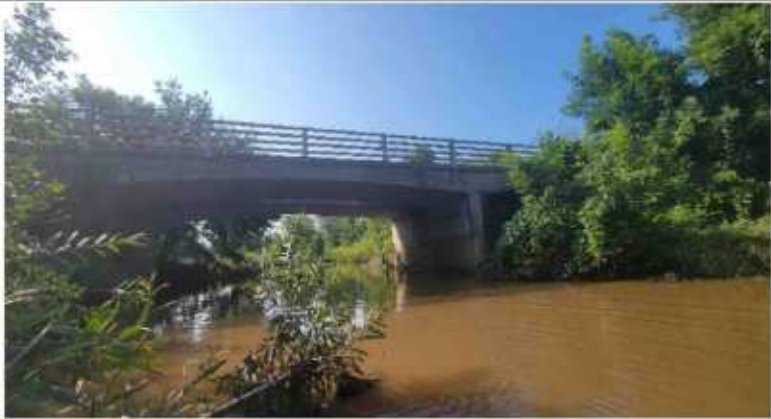
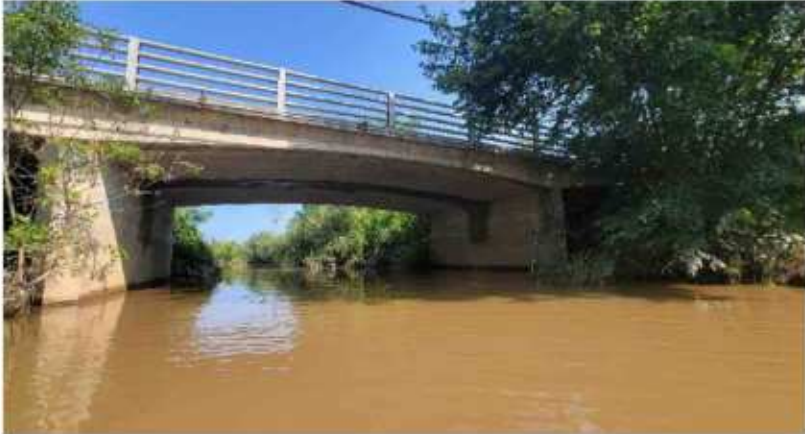
| <b>Additional Notes/Notable Obstructions:</b> | <p>pier rise east 1.83 - 0.85. length 5.01<br/> pier rise west 3.12. - 0.94. length 5.1</p> |

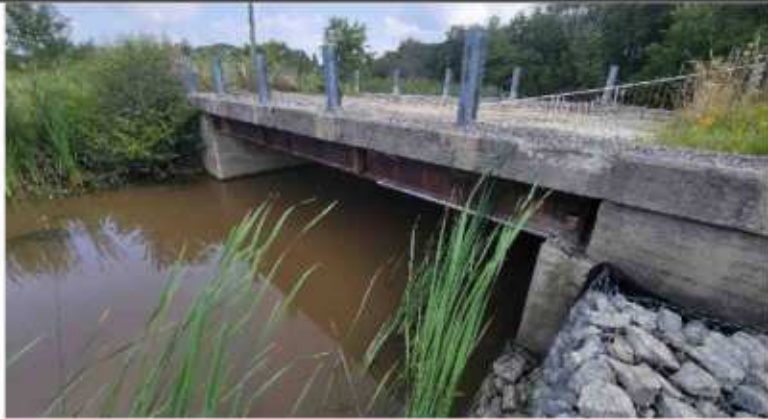
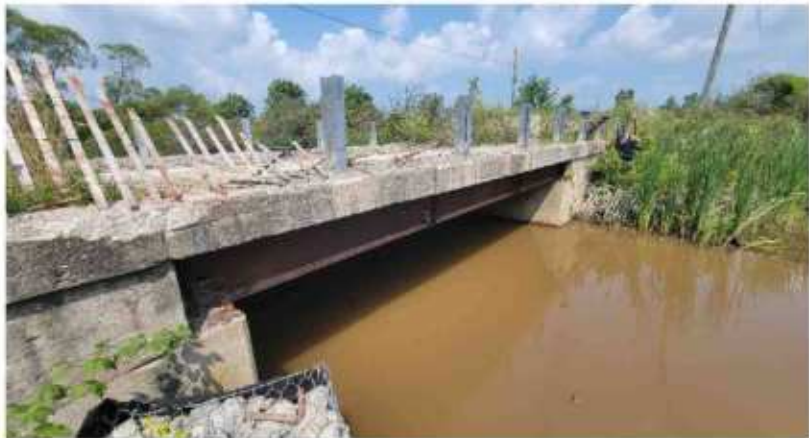
| <b>Additional Notes/Notable Obstructions:</b> | <p>bridge closed off</p> <p>U/S we1-2.3 bob2-2.83 b3-3.44 thal4-3.48 b5-3.45 bob6-2.8 we7-2</p> <p>D/S we8-2 bob9-2.93 b10-3.35 thal11-3.44 b12-3.45 bob13-2.82</p> <p><b>WATER ELEVATION ON US SIDE DIFFER BY 0.3m</b></p> |

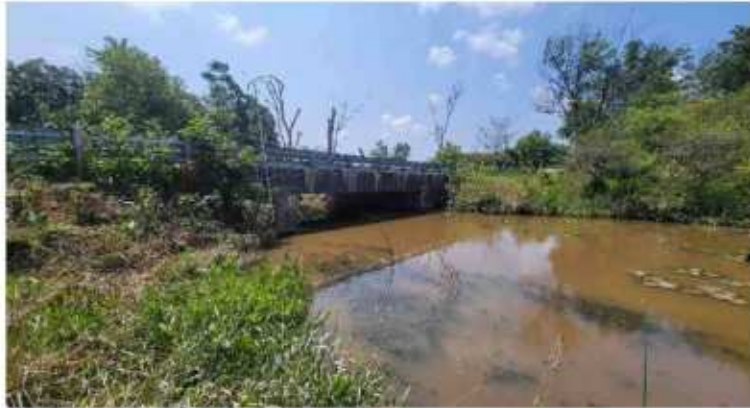
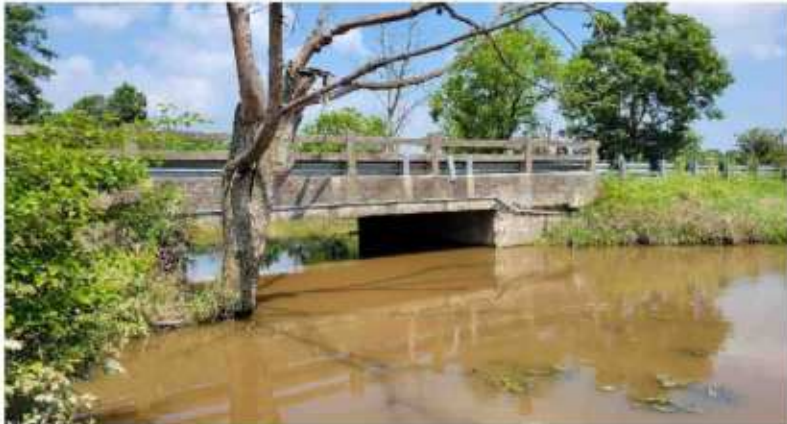
| <b>Additional Notes/Notable Obstructions:</b> | <p>U/S B1-3.18 b2-3.46 thal3-3.42 b4-3.32 b5-3.15<br/> D/S b6-2.91 b7-3.39 thal8-3.35 b9-3.16 b10-2.9<br/> <b>US THALWAG ELEVATION SKEWED</b></p> |

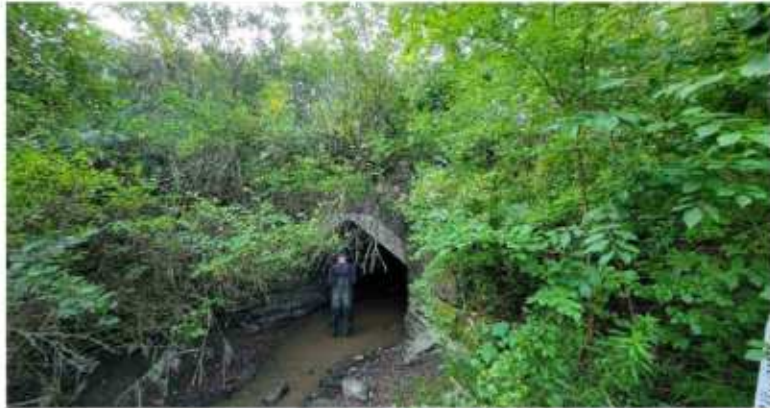
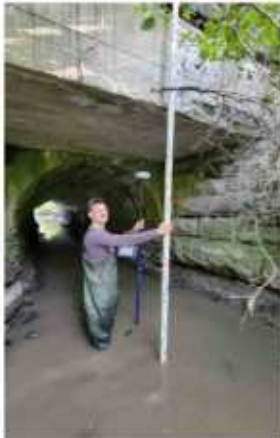
| <b>Additional Notes/Notable Obstructions:</b> | custom trapazodial concrete roof and armourstone walls<br>obv ds working 175.96<br>obv us working 177.47 |

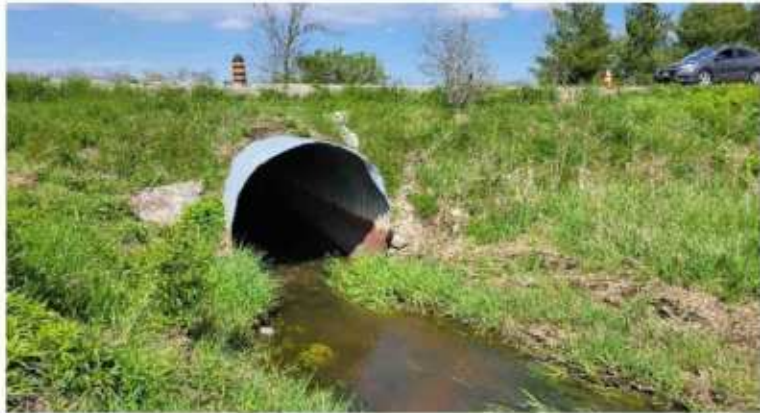
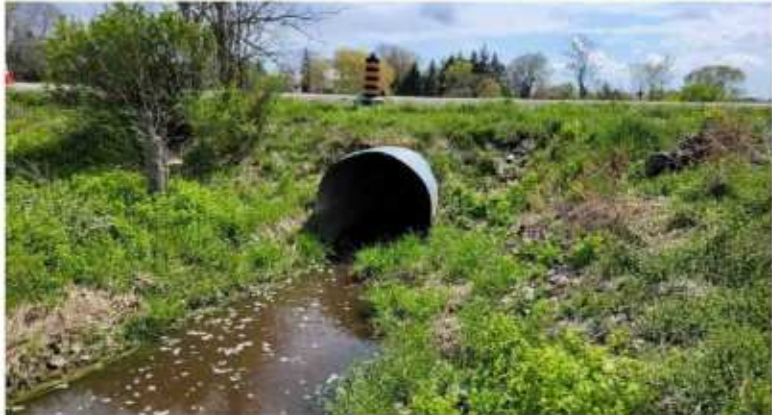
**Stream Crossing Field Inventory Sheet**  
Oswego Creek

| <b>Additional Notes/Notable Obstructions:</b> | Bottom of CSP corroding |

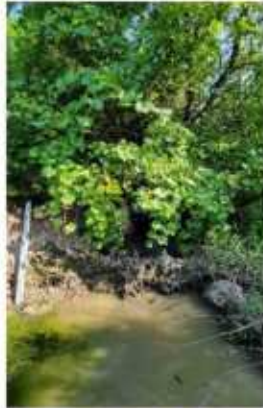
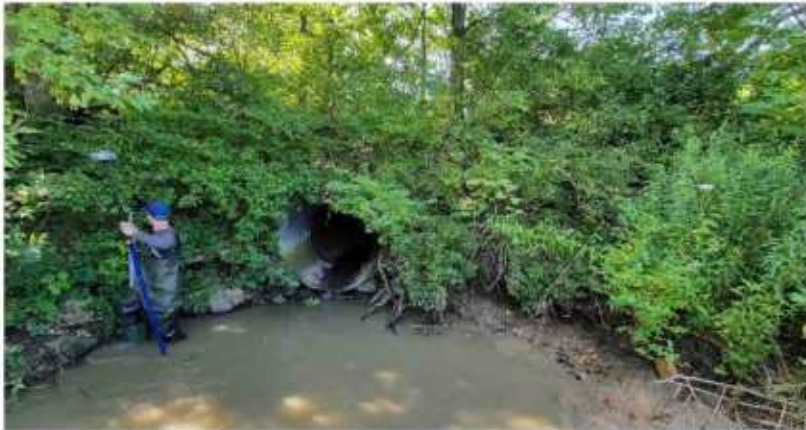
**Stream Crossing Field Inventory Sheet**  
Oswego Creek

| <b>Additional Notes/Notable Obstructions:</b> | CSP inlet and outlet pipes deteriorated 2.0m extentionms US and DS<br>US debris accumulation in CSP |

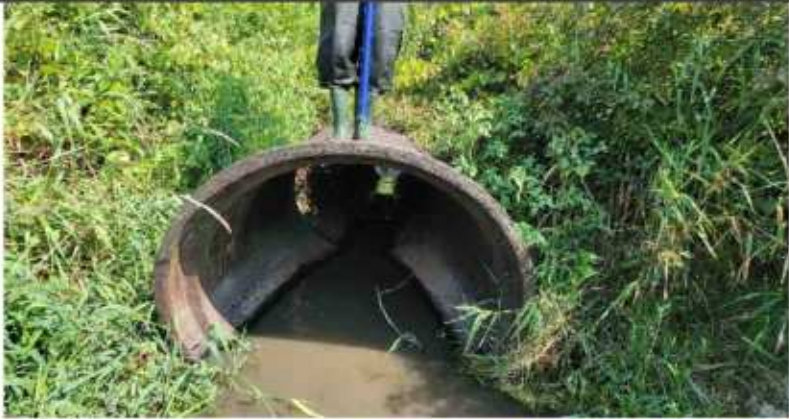
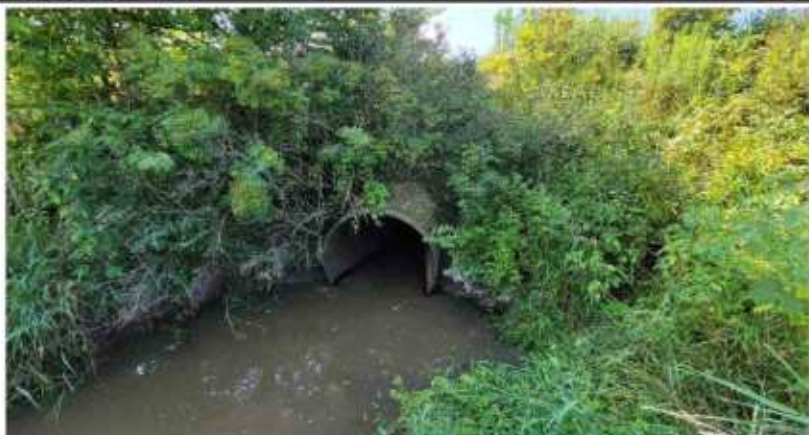
# Stream Crossing Field Inventory Sheet

| <b>Additional Notes/Notable Obstructions:</b> | road crossing downstream - CSP eleptical pipe 1.74m span ( survey points with X)<br>US and DS pipe sections broken off main |

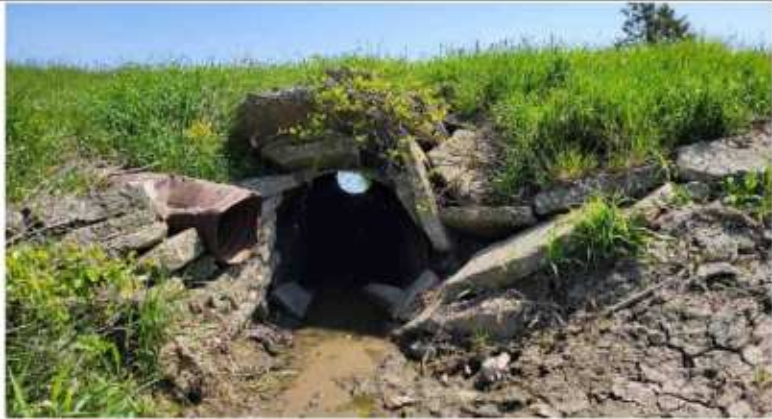
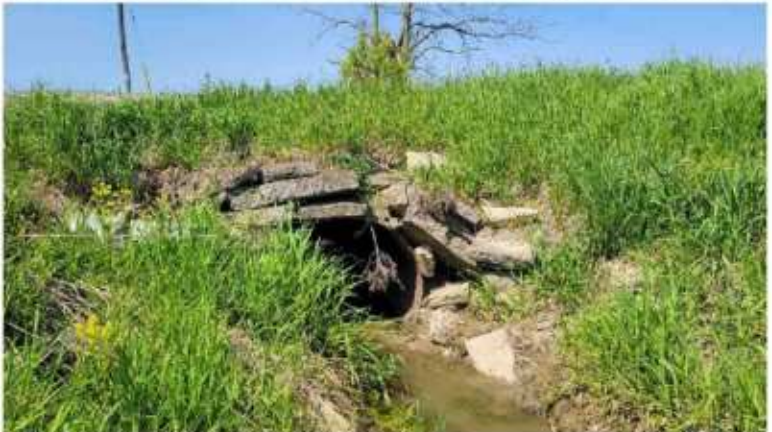
**Stream Crossing Field Inventory Sheet**  
Oswego Creek

| <b>Additional Notes/Notable Obstructions:</b> | Exposed natural gas line at DS end<br>Concrete rubble headwall |

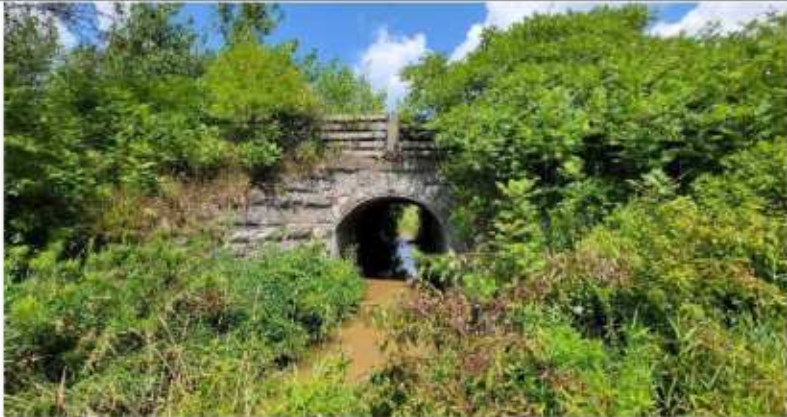
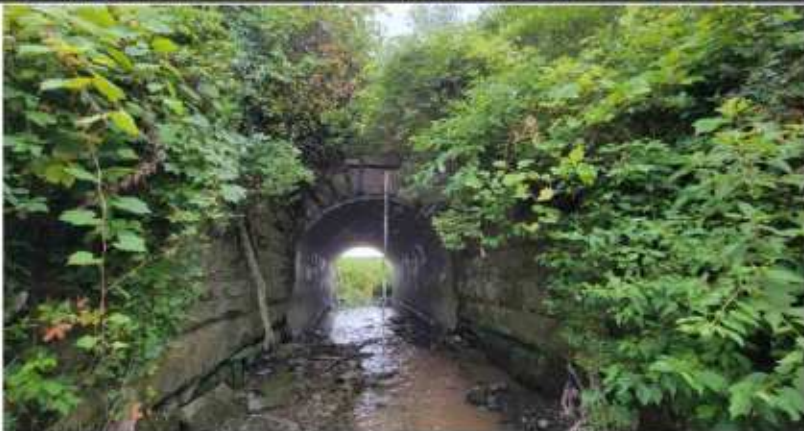
| <b>Water Depth (m):</b> | 0.24 |

| <b>Additional Notes/Notable Obstructions:</b> | <p>conc thickness 1.1m</p> <p>US wingwalls East perpendicular West 45 degree</p> <p>DS perpendicular wingwalls</p> |

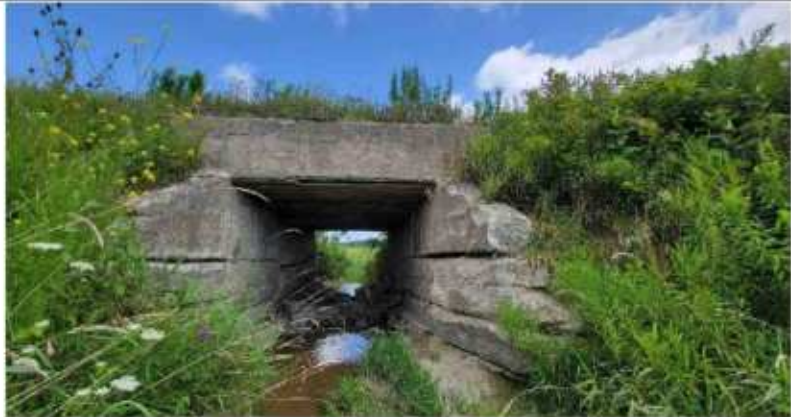
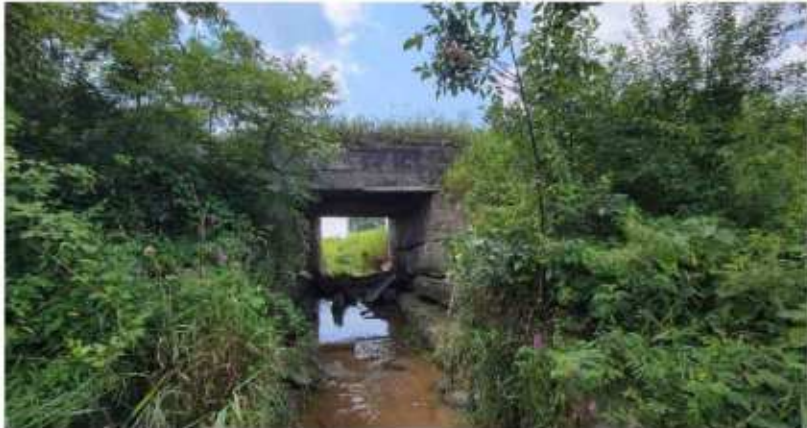
**Stream Crossing Field Inventory Sheet**  
Oswego Creek

| <b>Additional Notes/Notable Obstructions:</b> | top conc thickness 0.98m<br>concrete blocks deteriorating - upper roadway washedout |

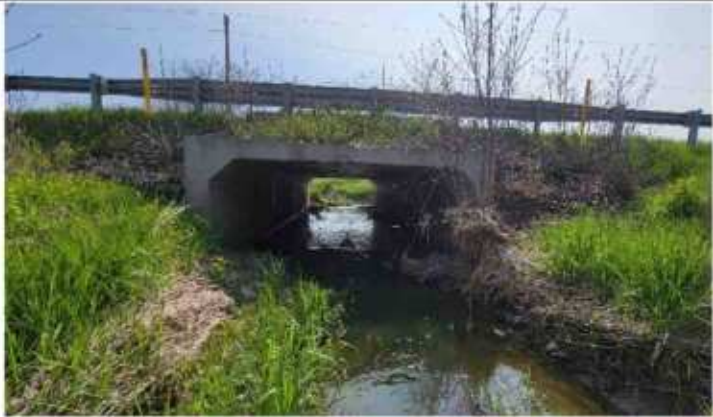
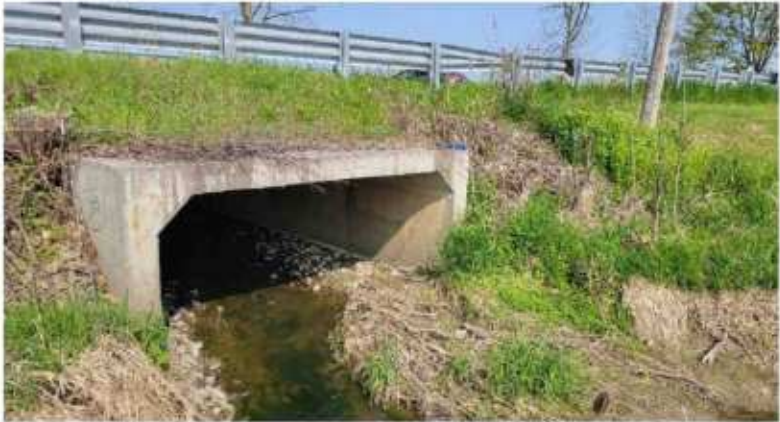
| <b>Water Depth (m):</b> | 0.28 |

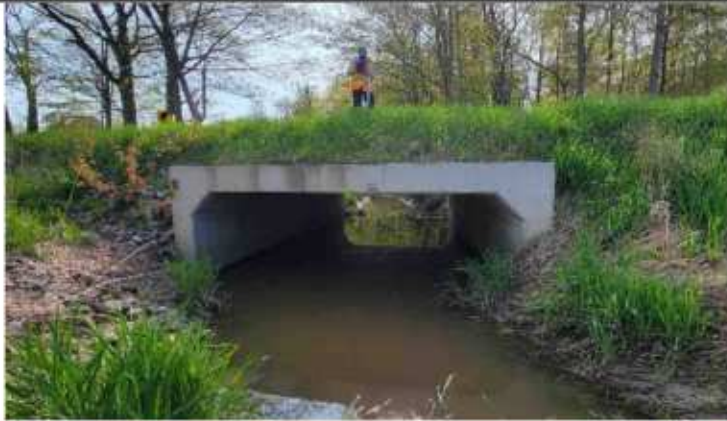
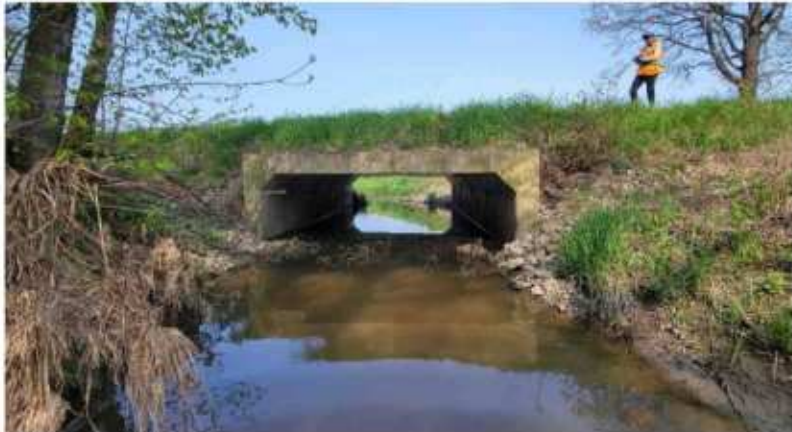
| <b>Water Depth (m):</b> | 0.27 |

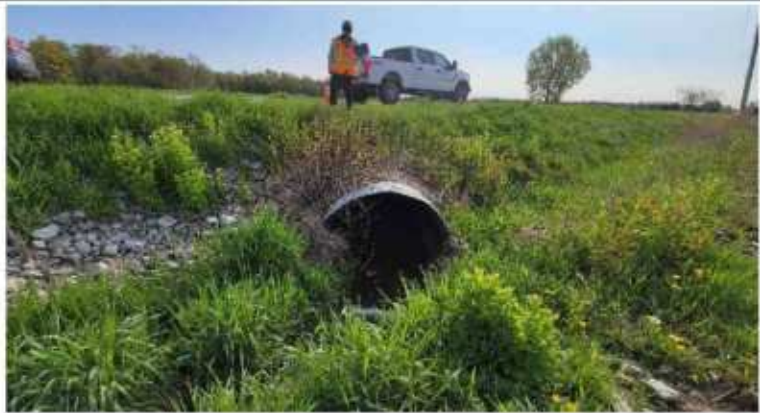
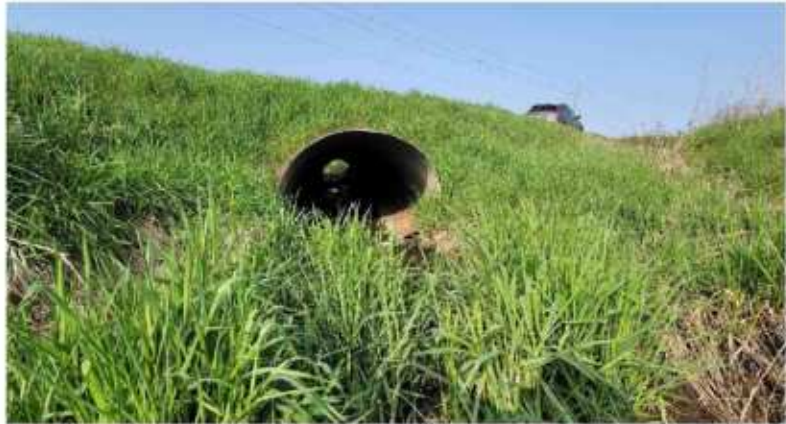
**Stream Crossing Field Inventory Sheet**  
Oswego Creek

| <b>Additional Notes/Notable Obstructions:</b> | Minor warping and corrosion at bottom of culvert at DS<br>US side has tile drains from agricultural field |

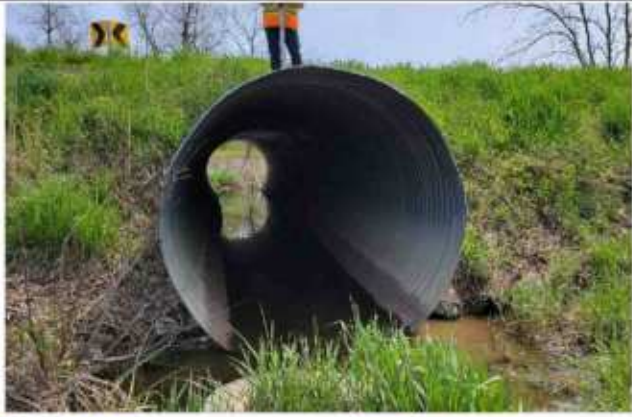
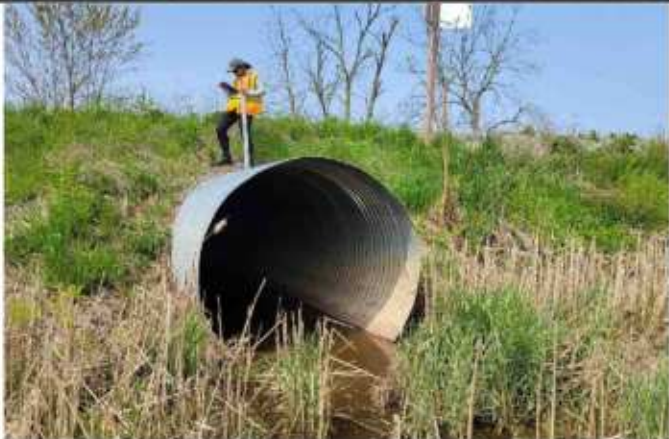
| <b>Water Depth (m):</b> | 0.14 |

| <b>Additional Notes/Notable Obstructions:</b> | US and DS has no defined channel, low land marsh |

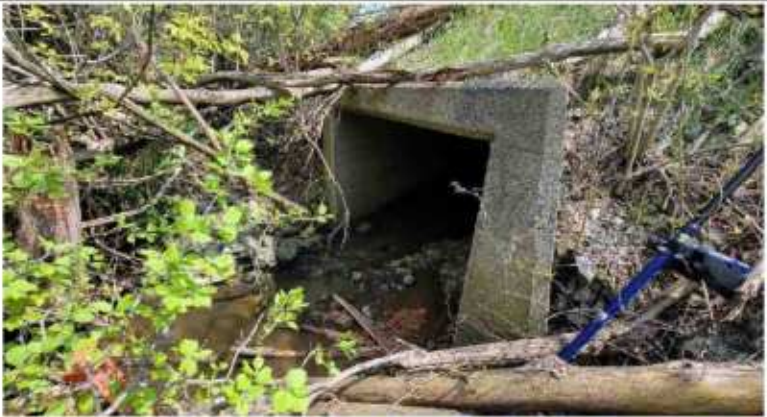
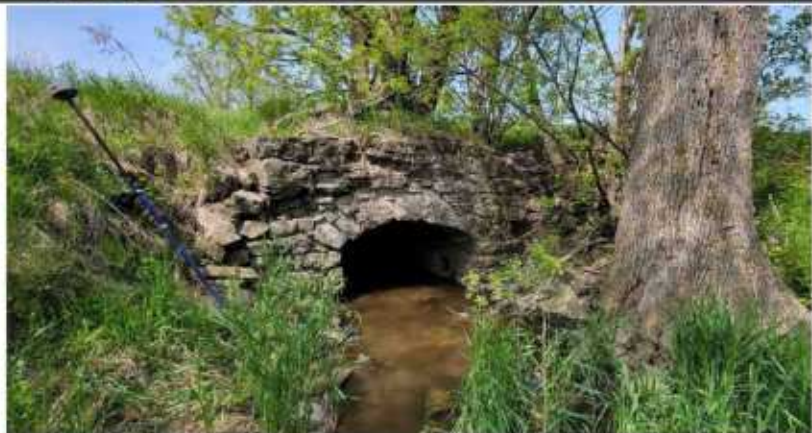
| <b>Additional Notes/Notable Obstructions:</b> | US side has large debris in channel<br>US box culvert thickness 0.26m<br>DS has 5.7m stone arch extension, face to box culvert bend is 11.5m |
