# OSWEGO CREEK FLOODPLAIN MAPPING

## HYDRAULIC REPORT

JANUARY 17, 2025

PROJECT 22-925

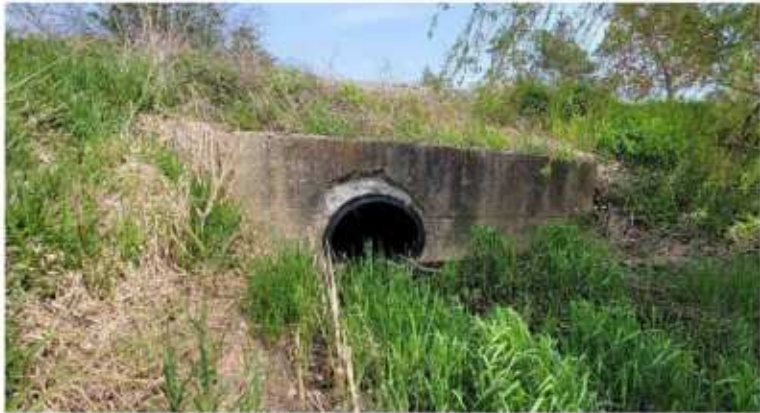
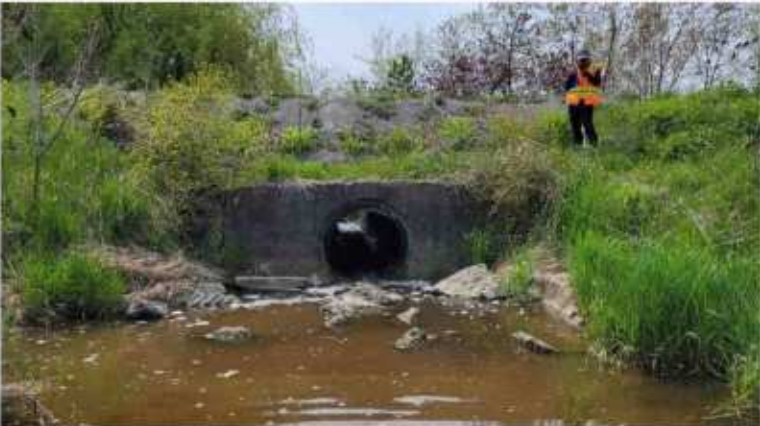
**Stream Crossing Field Inventory Sheet**  
Oswego Creek

| <b>Additional Notes/Notable Obstructions:</b> | Under private property driveway<br>Concrete debris in DS side channel |

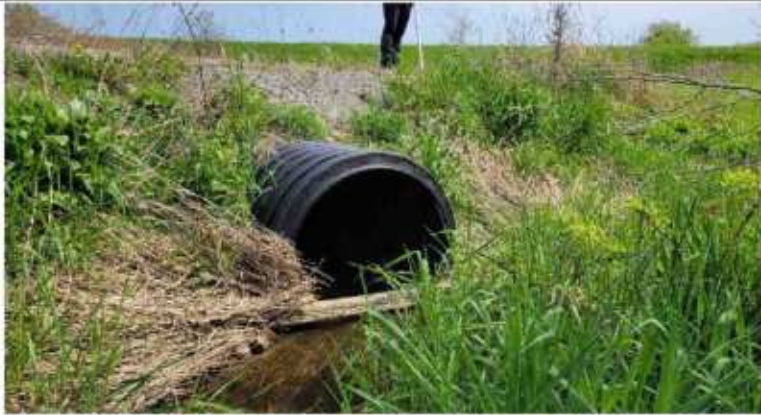
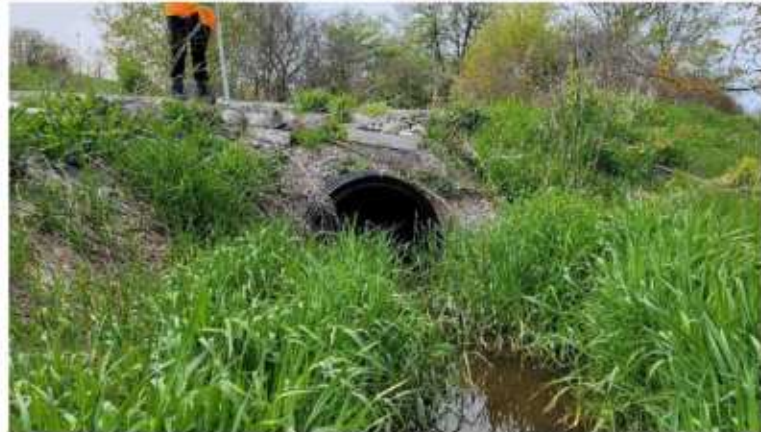
| <b>Water Depth (m):</b> | 0.3 |

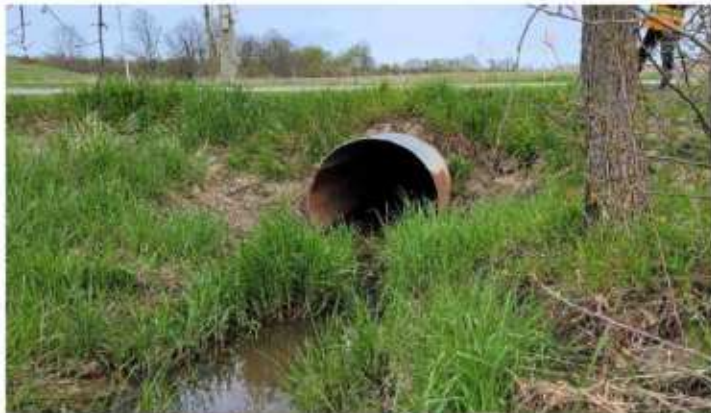
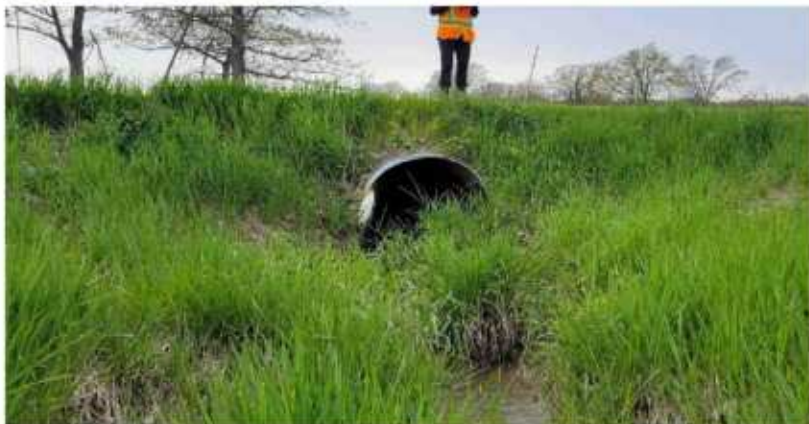
| <b>Water Depth (m):</b> | 0.2 |

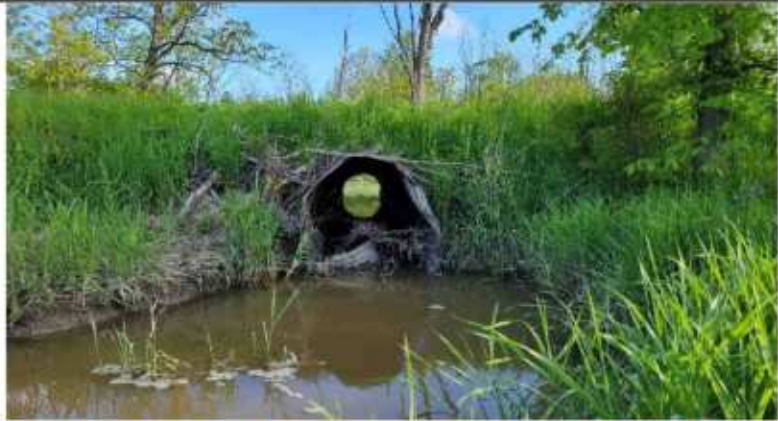
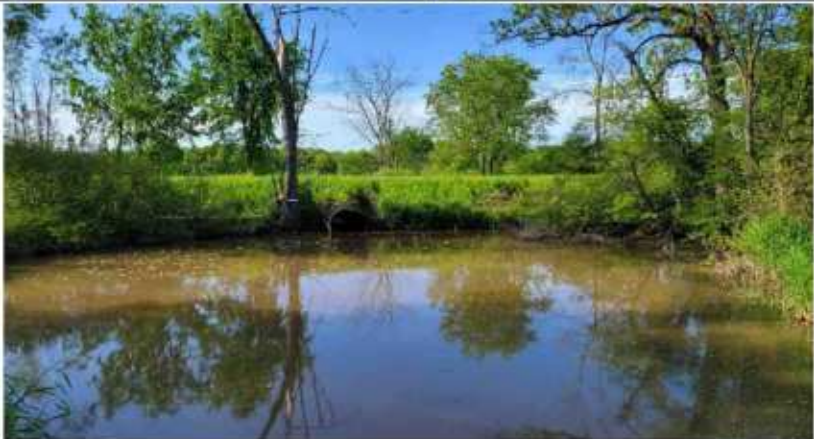
**Stream Crossing Field Inventory Sheet**  
Oswego Creek

| <b>Additional Notes/Notable Obstructions:</b> | Culvert Invert bent at US end |

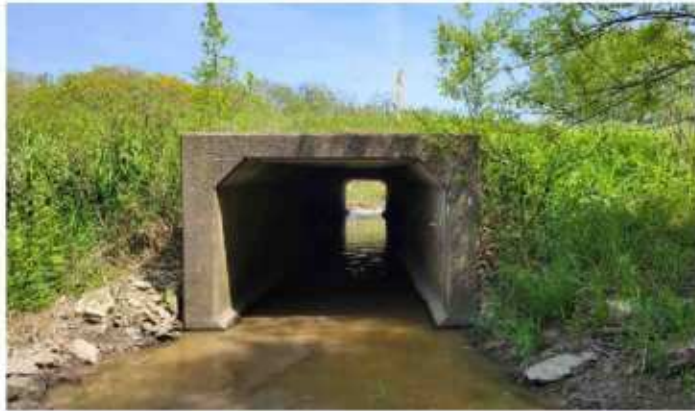
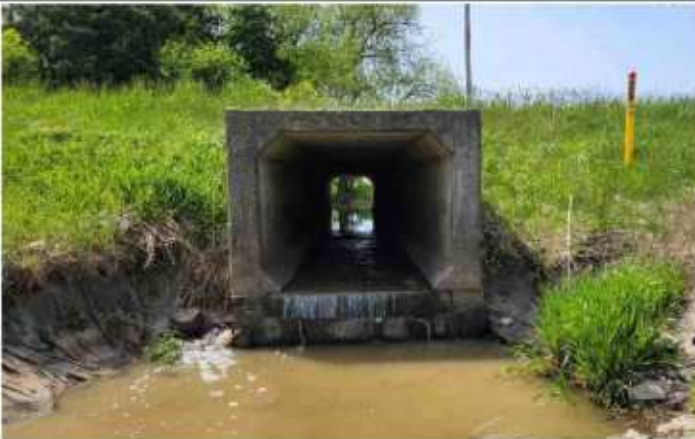
| <b>Water Depth (m):</b> | 0.22 |

| <b>Additional Notes/Notable Obstructions:</b> | Erosion on banks and underneath culvert on DS side, perched culvert |
