# Lower Four Mile Creek Rapid Geomorphic Assessment

**AHYDTECH Geomorphic Ltd.**

**APRIL 2026**

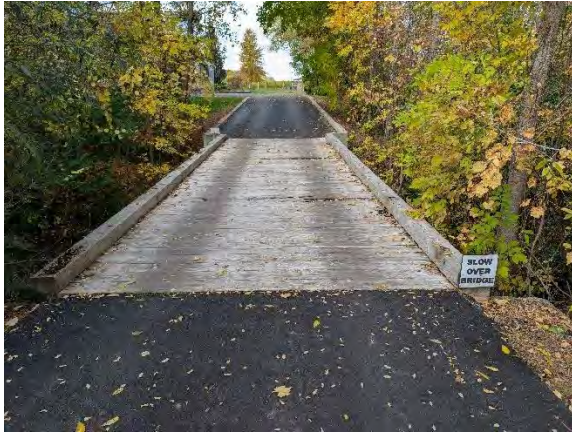
*Figure 4-1: Crossing Over the Creek*

During reconnaissance, the creek was observed to contain numerous fallen and broken trees, exposed root systems, and significant in-channel woody debris accumulations. These features are indicative of ongoing bank erosion, toe scour, and localized channel instability in several reaches. In many locations, exposed roots and undercut banks suggest active lateral adjustment processes. Indicators of geomorphic adjustment, including bank undercutting, localized slumping, and erosion-prone banks, were identified along several reaches. These

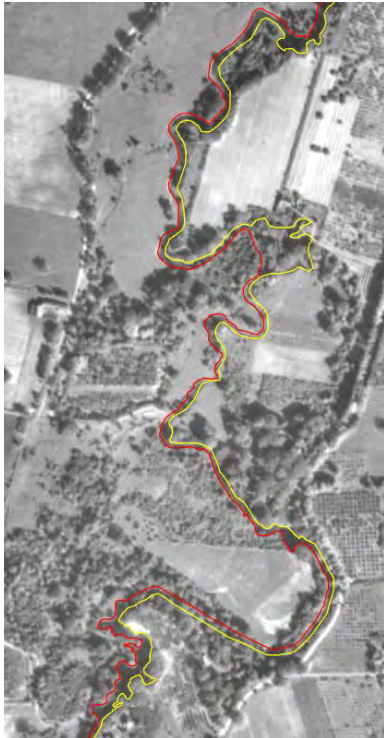
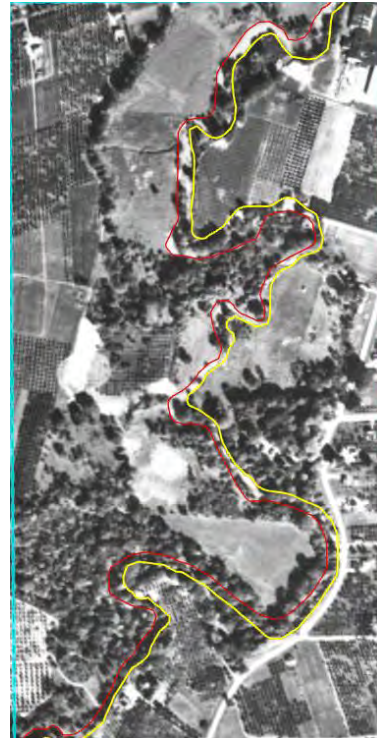
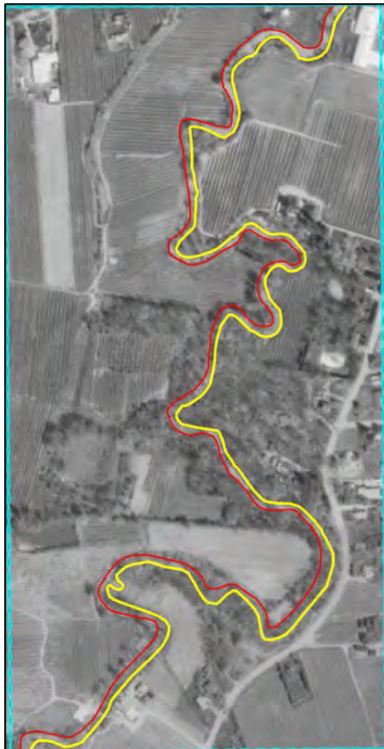
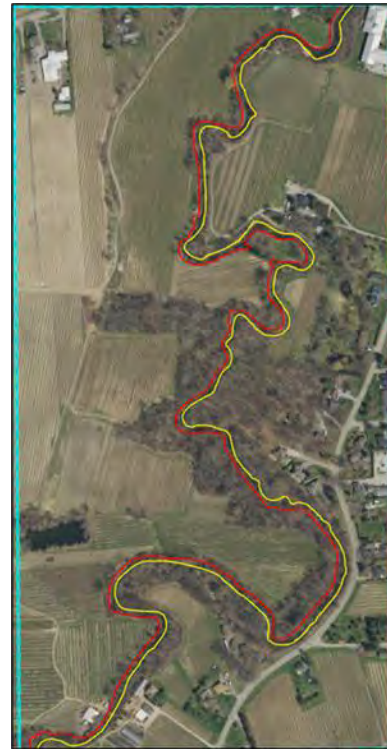
Banklines were digitized consistently for each image set and compared across the four periods. The analysis indicates that the creek has generally maintained a sinuous planform, with localized lateral migration occurring primarily along outer meander bends. Several bends show gradual bank retreat over time, while other sections exhibit relatively stable bank positions with minimal change between the imagery years.

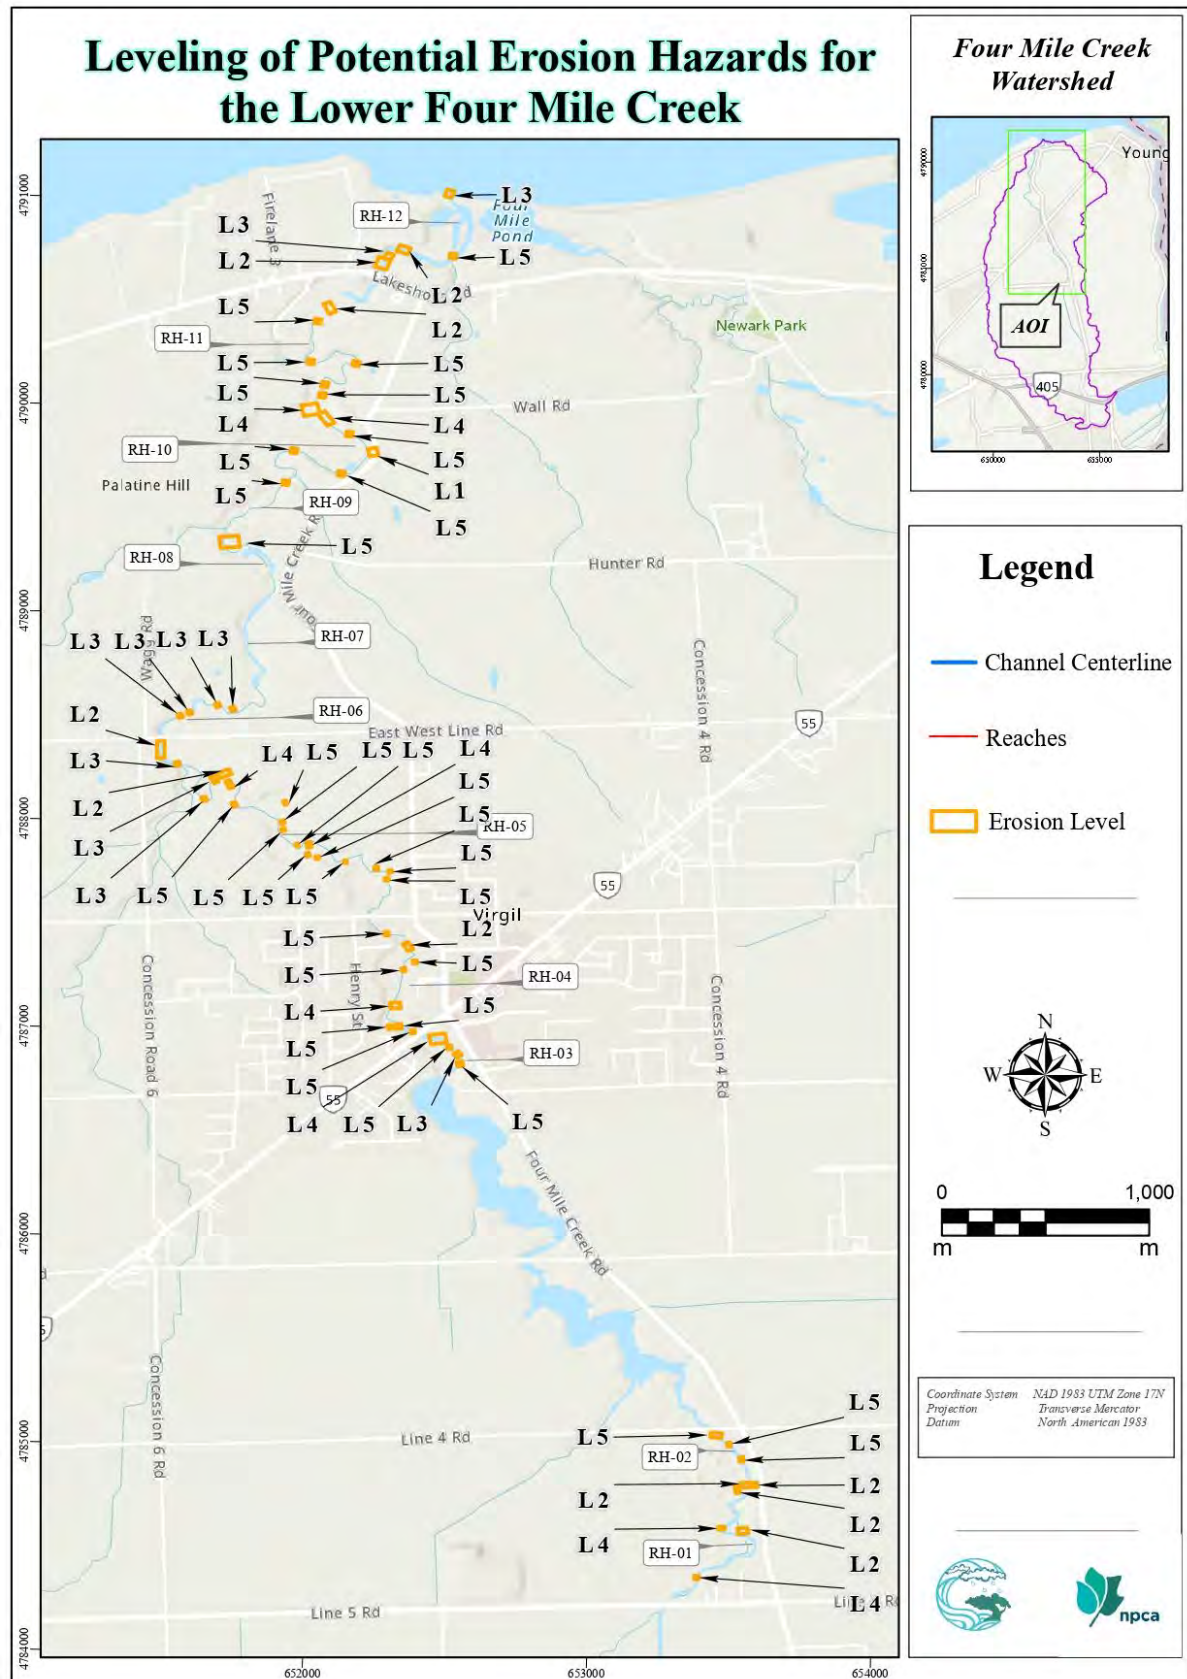
**Figure 8-1: Potential Erosion Hazards Locations**

Mapped locations corresponding to these severity levels are identified as L1 through L5 on **Figure 8-1**. Detailed reach-wise illustrations of the potential erosion hazards are presented in **Figure 8-2** through **Figure 8-8**. Selected photographs of the identified potential erosion hazard locations are provided in **APPENDIX D: Images of Potential Erosion Hazard Locations**.

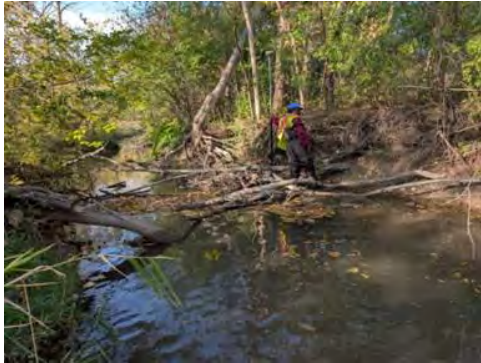
| Reach | Priority/<br>Severity | Image | Issues | Opportunities<br>for Restoration |
|---|---|---|---|---|
| <b>Reach 01</b> | Level 2 | | Significant bank erosion accompanied by broken trees and branches, contributing to severe instability | Removal of debris and targeted structural stabilization is recommended to protect the bank and adjacent areas. |

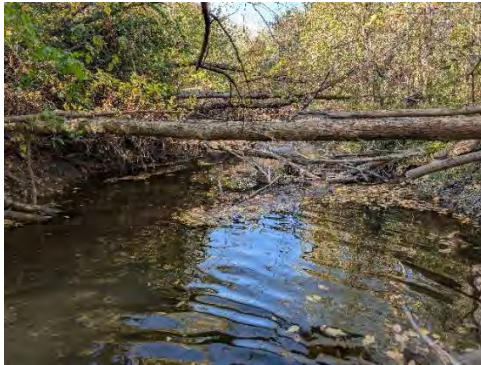
| Reach | Priority/<br>Severity | Image | Issues | Opportunities<br>for Restoration |
|---|---|---|---|---|
| <b>Reach 02</b> | Level 5 | | A fallen tree spanning the channel, with branches and accumulated debris, is disrupting flow and exacerbating bank erosion | Removal of the obstruction and reinforcement of the adjacent bank with vegetation or structural support is recommended. |

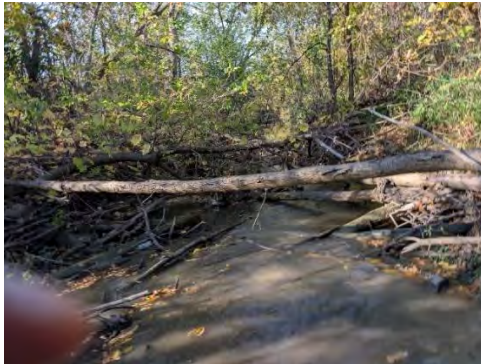
| Reach | Priority/<br>Severity | Image | Issues | Opportunities<br>for Restoration |
|---|---|---|---|---|
| <b>Reach 02</b> | Level 3 | | Fallen trees and exposed roots within the channel are obstructing flow and contributing to localized instability | Clearing of obstructions followed by establishment of riparian vegetation is recommended to restore channel function. |

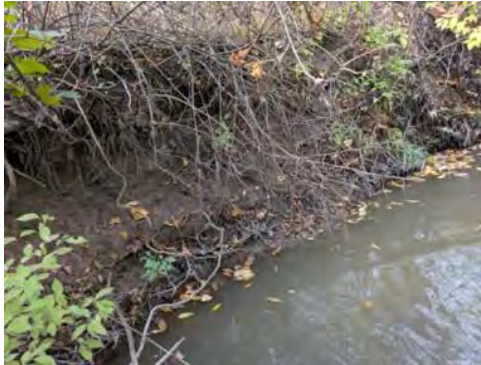
| Reach | Priority/<br>Severity | Image | Issues | Opportunities<br>for Restoration |
|---|---|---|---|---|
| <b>Reach 03</b> | Level 3 | | Significant bank erosion with extensive exposed roots, contributing to localized instability | Stabilization through vegetation and supplemental planting is recommended to reduce further soil loss. |

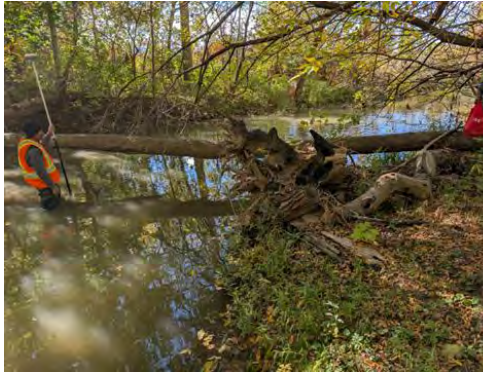
| Reach | Priority/<br>Severity | Image | Issues | Opportunities<br>for Restoration |
|---|---|---|---|---|
| Reach 05 | Level 5 | | Fallen tree and exposed root along the bank, causing minor local disruption | Opportunities exist to enhance stability and habitat through natural vegetation and root-based structures. |

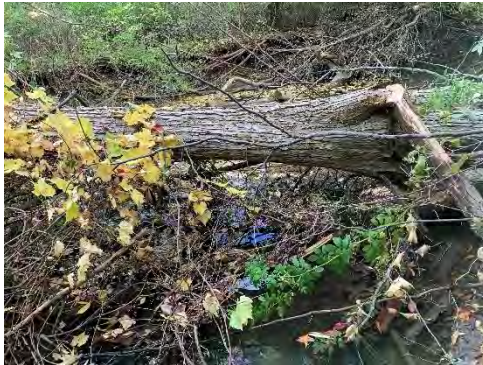
| Reach | Priority/<br>Severity | Image | Issues | Opportunities<br>for Restoration |
|---|---|---|---|---|
| <b>Reach 08</b> | Level 5 | | Uprooted trees have fallen into the creek, contributing to debris accumulation and localized flow disruption | Clearing the obstruction and encouraging natural vegetation growth along the banks could help re-stabilize the area. |

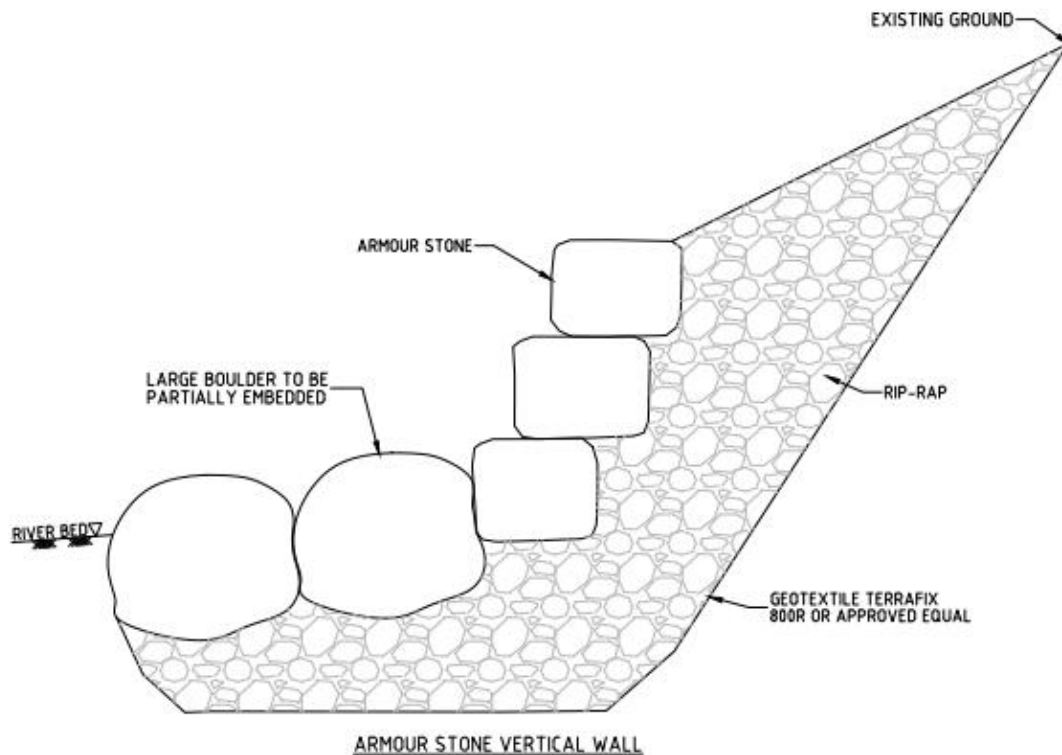
Figure 9-1: Armour stone vertical wall typical cross-section (Structure 1).

This is a bank erosion protection structure with a hard-armoured, near-vertical bank protection system comprising stacked armour stones on a prepared foundation, backed by a graded riprap / granular transition zone and separated from native soils by a geotextile filter layer. It has large, embedded boulders at the toe to provide a robust launchable foundation and improve resistance to toe scour. **(Figure 9-1)**

**Design considerations:** Embedment depth and toe keying should account for expected scour depth and bed mobility; tie-ins upstream and downstream should be flared and keyed to avoid end-around erosion; transitions to adjacent natural bank should be graded and vegetated where space allows; and the wall height should be limited to the minimum required to address the risk driver (e.g., infrastructure offset and bank height).

**Maintenance:** Annual inspection and post-event inspection should focus on toe displacement, void development, stone breakage, and evidence of flanking at the upstream/downstream tie-ins.

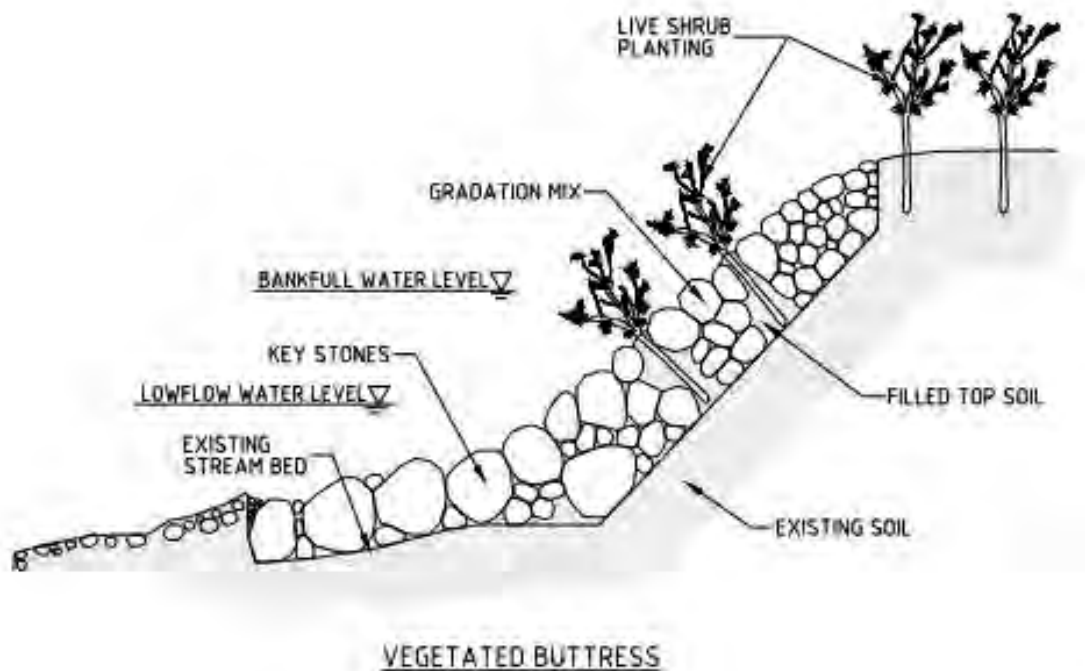
Figure 9-2: Vegetated buttress typical cross-section (Type 1) (Structure 2).

Vegetated Buttress (Type 1) is a hybrid stabilization measure that combines a rock buttress (key stones and a well-graded gradation mix) with live shrub planting and live staking to reinforce the upper bank. The buttress provides toe protection and a stable, roughened bank surface while allowing a vegetated bankline to establish over time. **(Figure 9-2)**

**Design considerations:** Rock sizing and thickness should be selected for expected near-bank shear stresses; the buttress crest should remain below or near bankfull where feasible to promote vegetation establishment; planting zones should be protected from high-velocity concentration by maintaining roughness and avoiding local flow constriction; and irrigation/temporary watering may be required in the first growing season.

**Maintenance:** Inspect after spring freshet and major storm events for stone displacement and loss of planted materials; replace failed plantings and re-compact/repair localized slumps as needed.

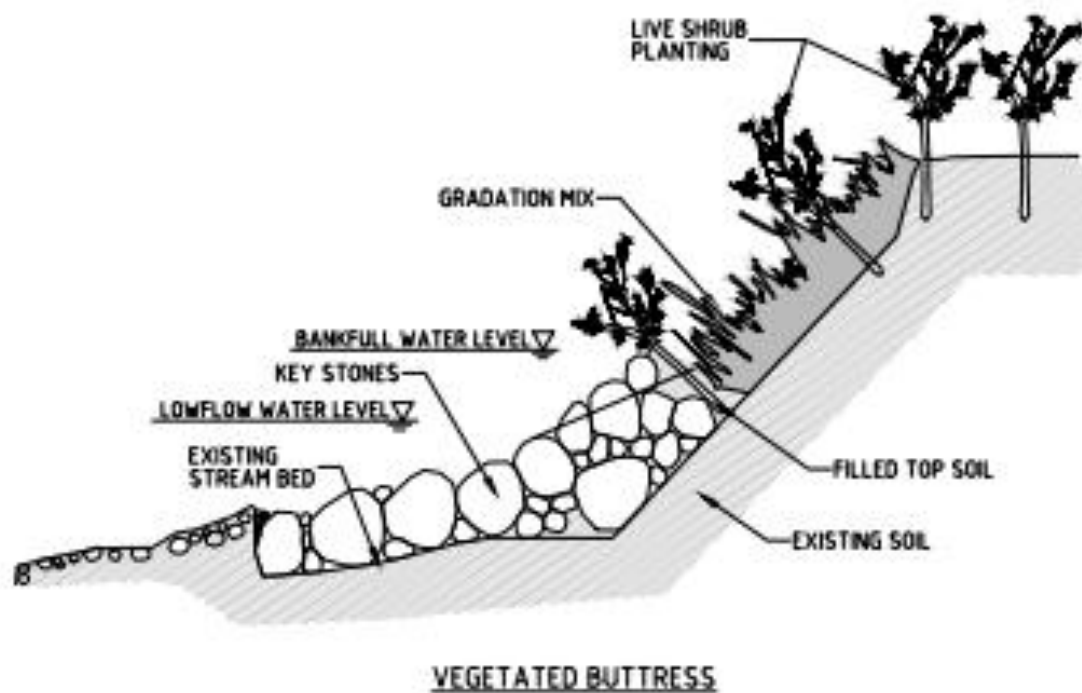
Figure 9-3: Vegetated buttress typical cross-section (Type 2) (Structure 3).

Vegetated Buttress (Type 2) is a moderated version of the vegetated buttress that retains key stones and a smaller rock buttress, while emphasizing vegetated reinforcement along the mid-bank and upper bank. The concept is suited to localized instability where full structural protection is not required. (*Figure 9-3*)

**Design considerations:** Ensure the toe is keyed into the bed to prevent undercutting; limit buttress footprint to minimize channel narrowing; integrate bank grading to remove over-steepened faces; and prioritize native species selection to match site moisture and shade conditions.

**Maintenance:** Similar to Level 2, with particular focus on early vegetation establishment and localized toe scour.

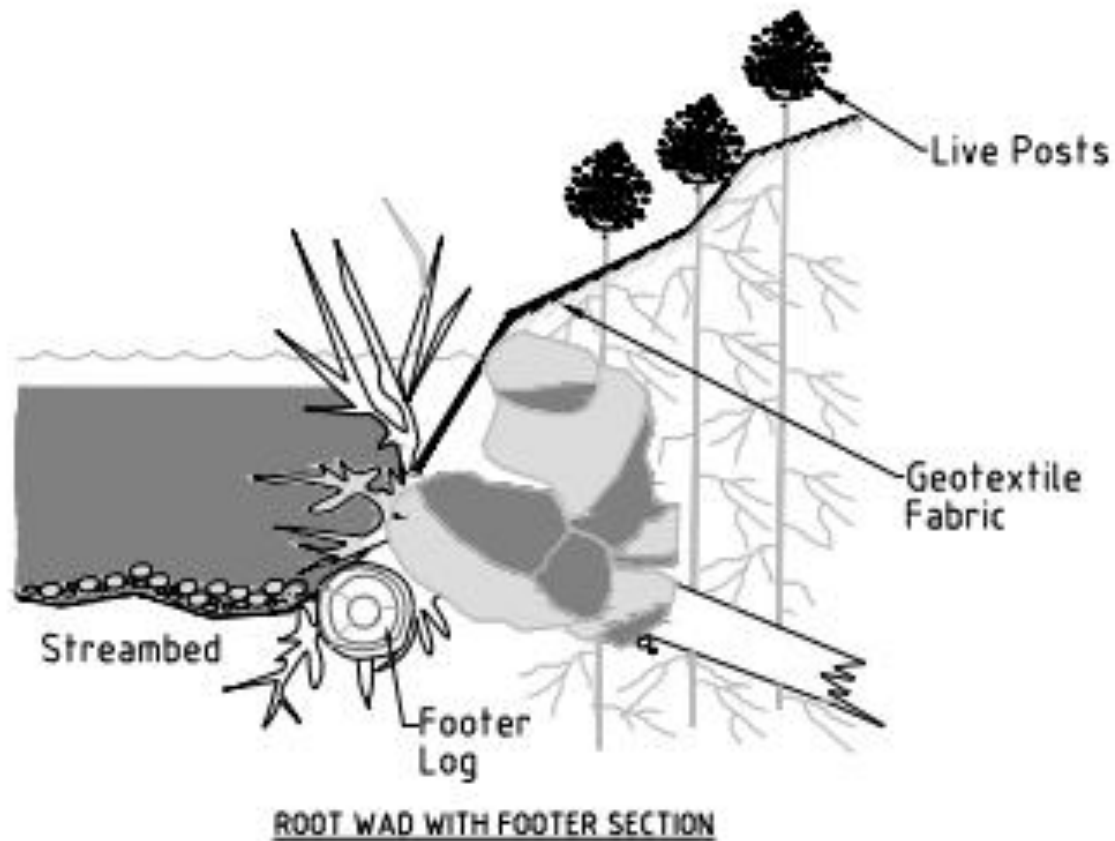
Figure 9-4: Root wad with footer section typical detail (Structure 4).

This is a habitat-forward stabilization detail that uses embedded woody material (root wad) keyed into the bank toe and tied to a footer log and/or boulder cluster. Geotextile fabric and live posts in the bank provide soil retention and vegetative reinforcement above the structure. (Figure 9-4)

**Design considerations:** Root wads should be keyed into the bank and ballasted/anchored to resist buoyancy and drag; embedment depth should anticipate bed mobility; orientation should avoid creating excessive local scour at adjacent untreated areas; and upstream/downstream transitions should include smaller woody elements or light rock to avoid flanking.

**Maintenance:** Inspect after high flows for displacement of the root wad or footer log, undermining at the toe, and damage to live posts; replace or re-secure woody elements as needed.

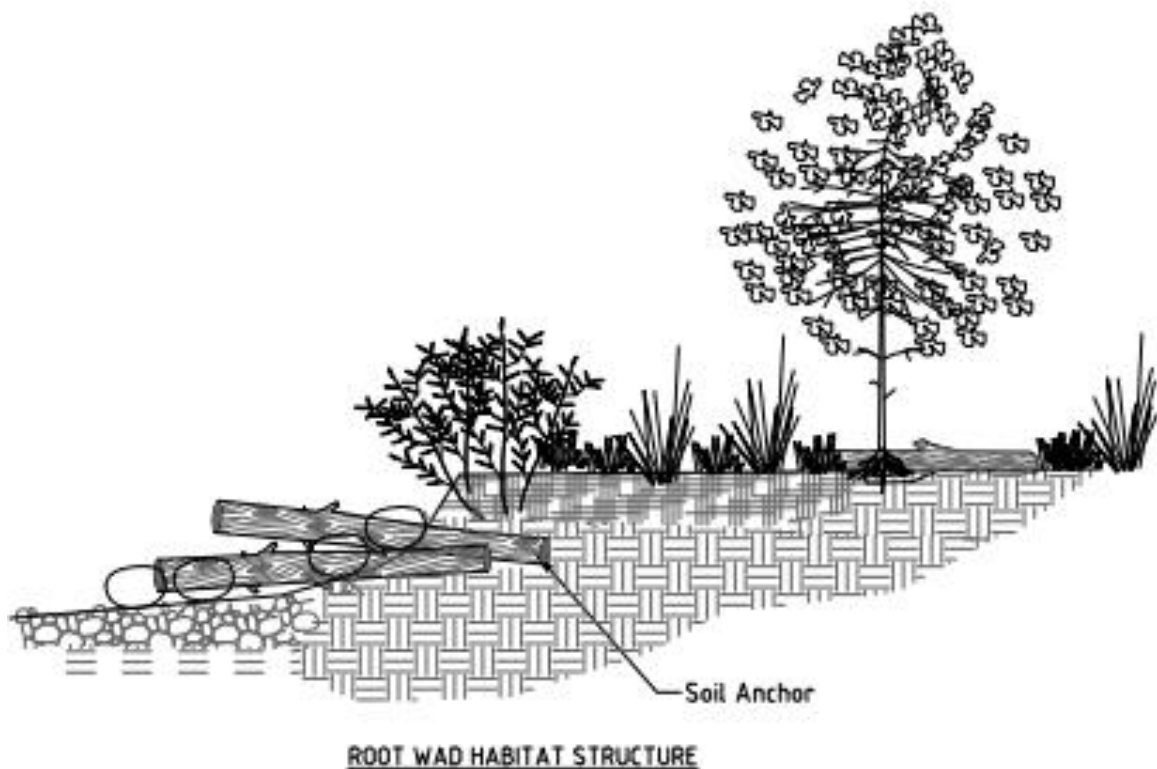
Figure 9-5: Root wad habitat structure typical detail (Structure 5).

A habitat structure consisting of placed woody material along the bank margin (logs/root elements) anchored to the bank (soil anchor) to provide cover, near-bank roughness, and minor flow deflection. (**Figure 9-5**)

**Design considerations:** Locate structures where they will not redirect flow toward the opposite bank or infrastructure; avoid installation in locations prone to ice jamming or debris accumulation unless the intent is to promote controlled wood retention; and ensure anchoring capacity is adequate for design flow drag forces.

**Maintenance:** Periodic inspection for loosening anchors or mobilized wood; reposition or remove elements if they pose a blockage risk at crossings.

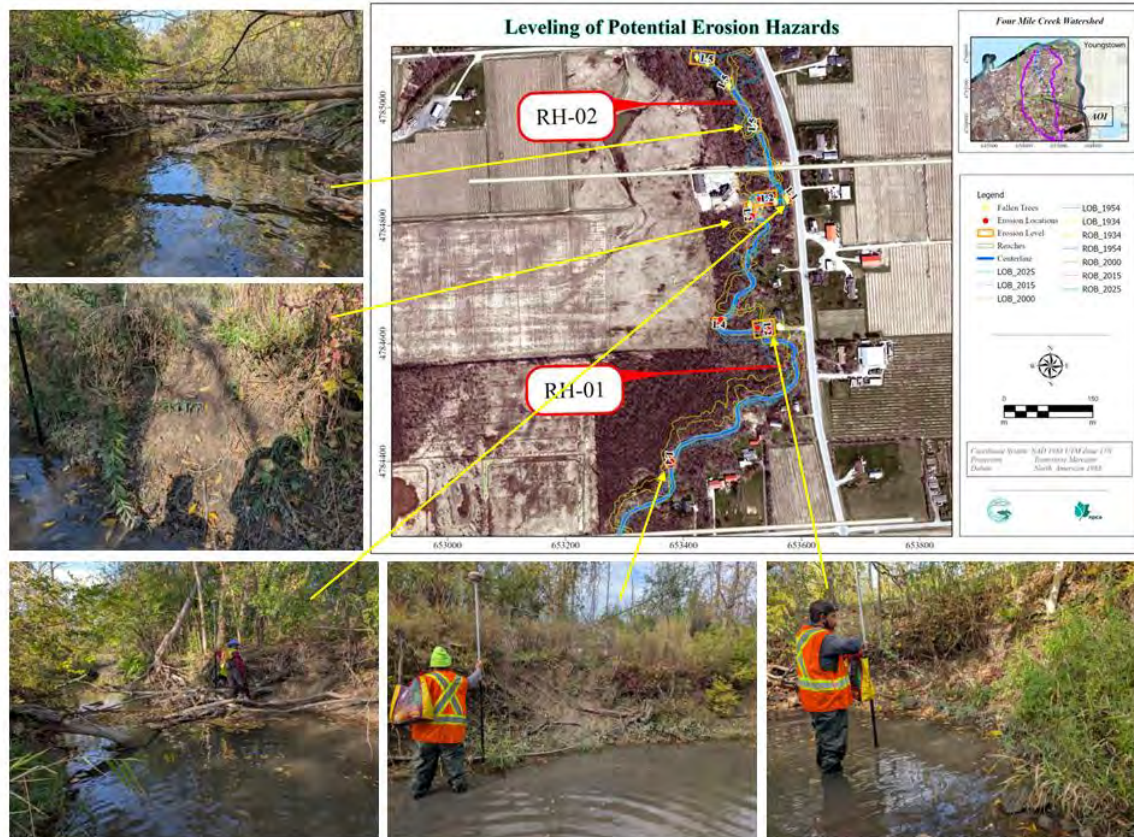
Figure 1: Images of Potential Erosion Hazard Locations Reach 01 and 02

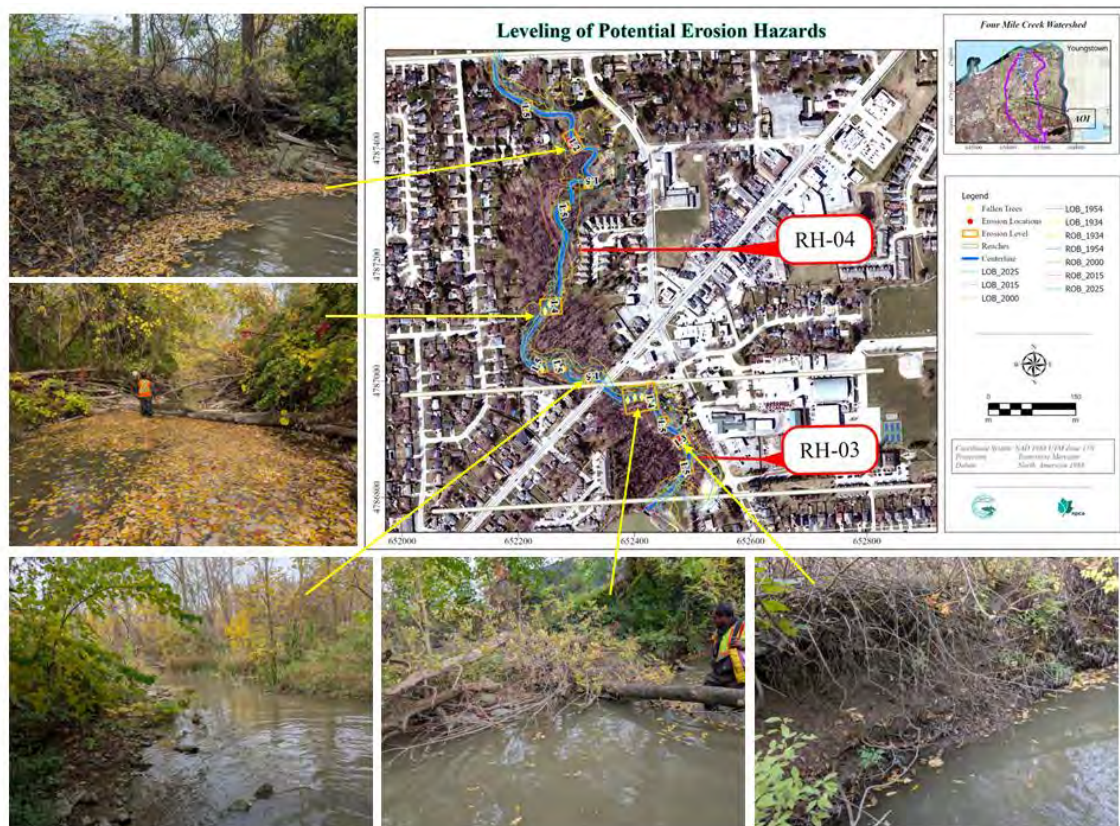
Figure 2: Images of Potential Erosion Hazard Locations Reach 03 and 04

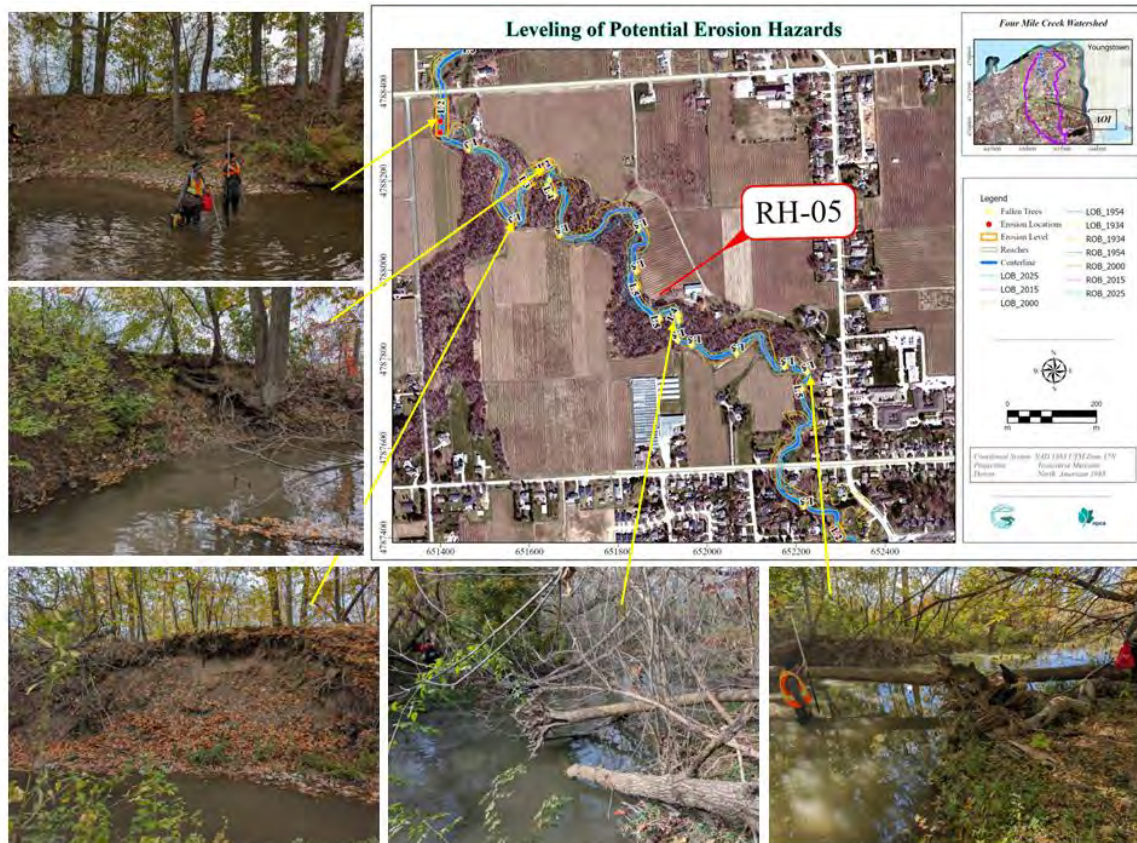
Figure 3: Images of Potential Erosion Hazard Locations Reach 05

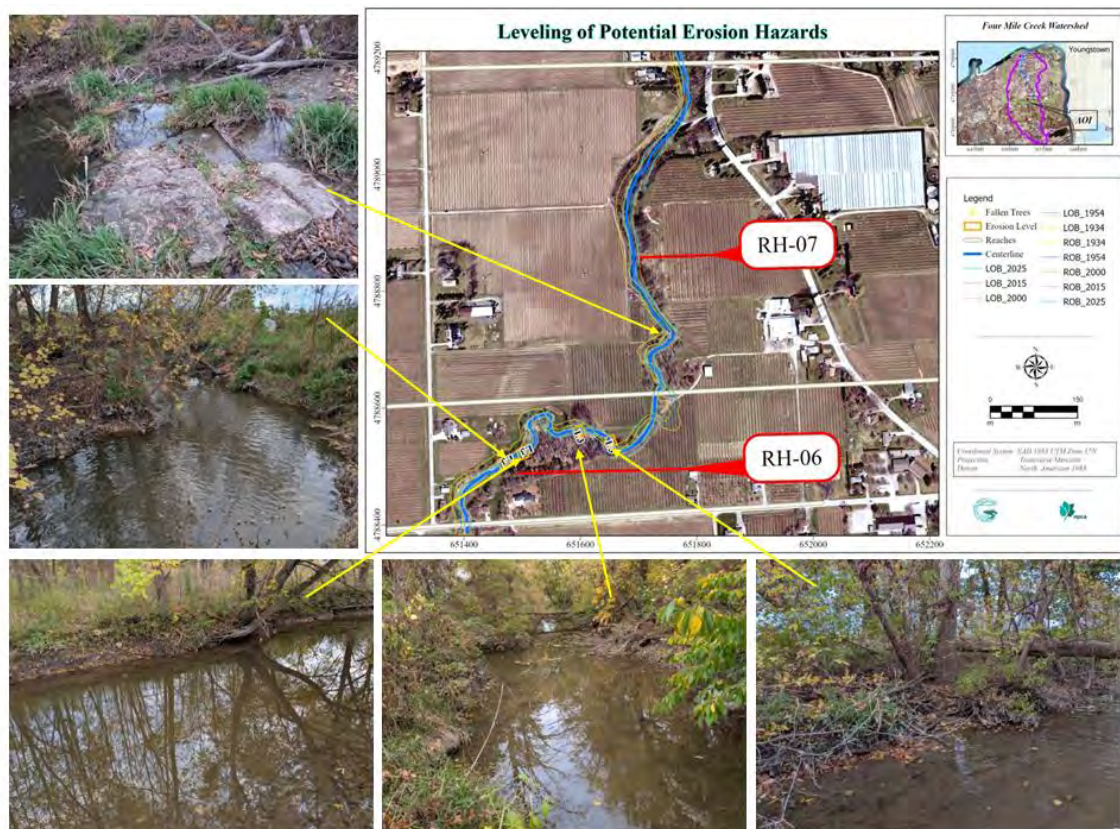
Figure 4: Images of Potential Erosion Hazard Locations Reach 06 and 07

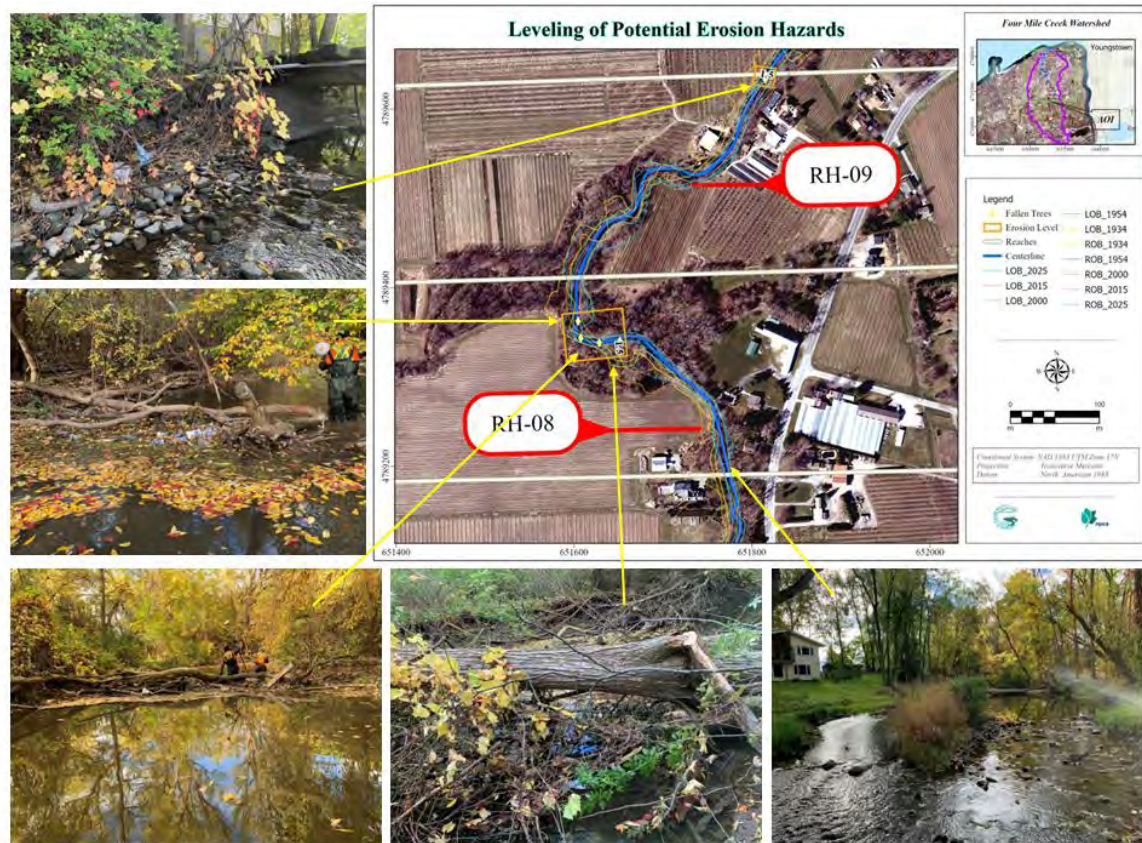
Figure 5: Images of Potential Erosion Hazard Locations Reach 08 and 09

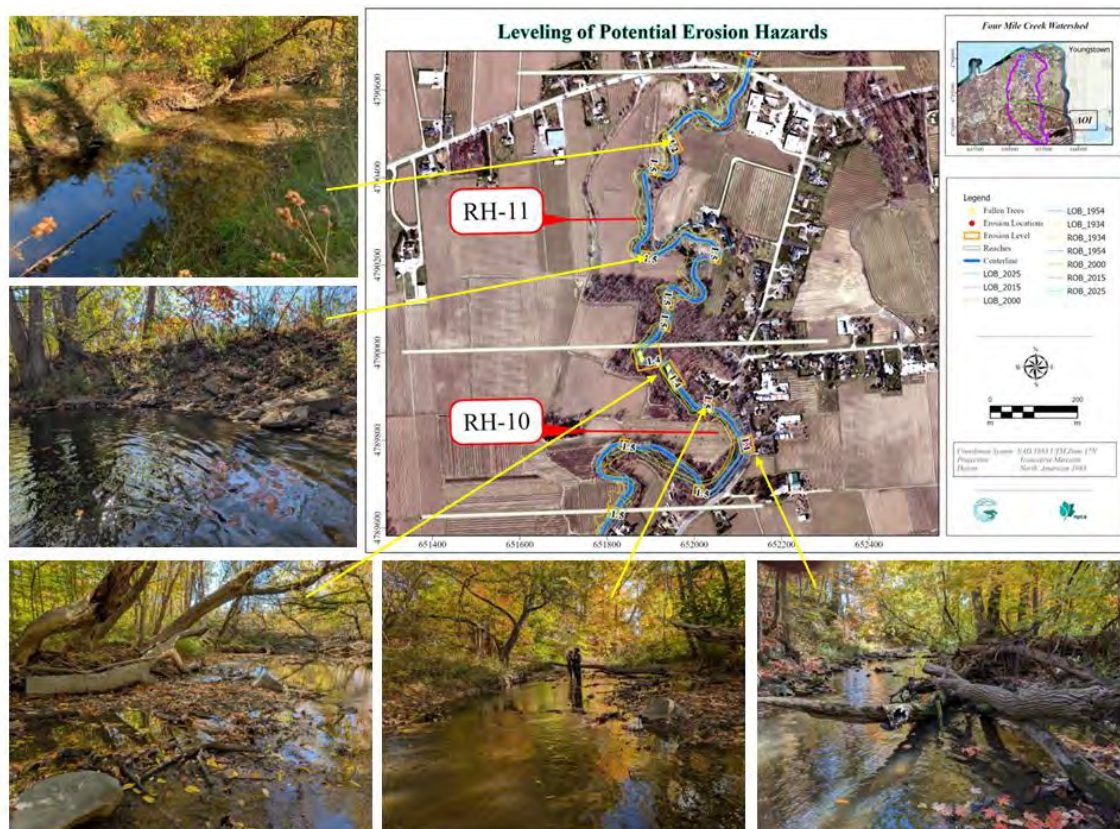
Figure 6: Images of Potential Erosion Hazard Locations Reach 10 and 11

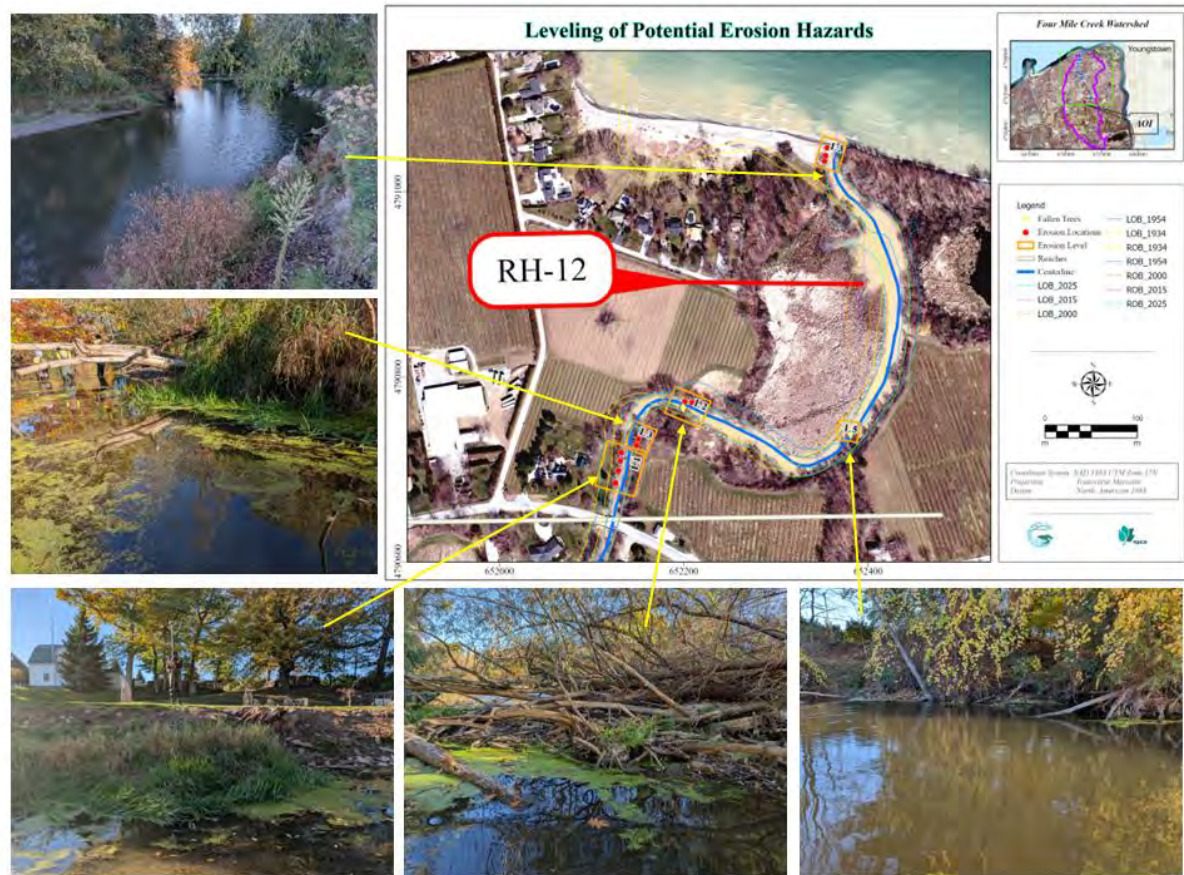
*Figure 7: Images of Potential Erosion Hazard Locations Reach 12*
